# UPPER, MIDDLE, AND LOWER POTOMAC RIVER

## WATERSHED ASSESSMENT

MAY | 2018

KCI TECHNOLOGIES, INC.  
936 RIDGEBROOK ROAD  
SPARKS, MD 21152

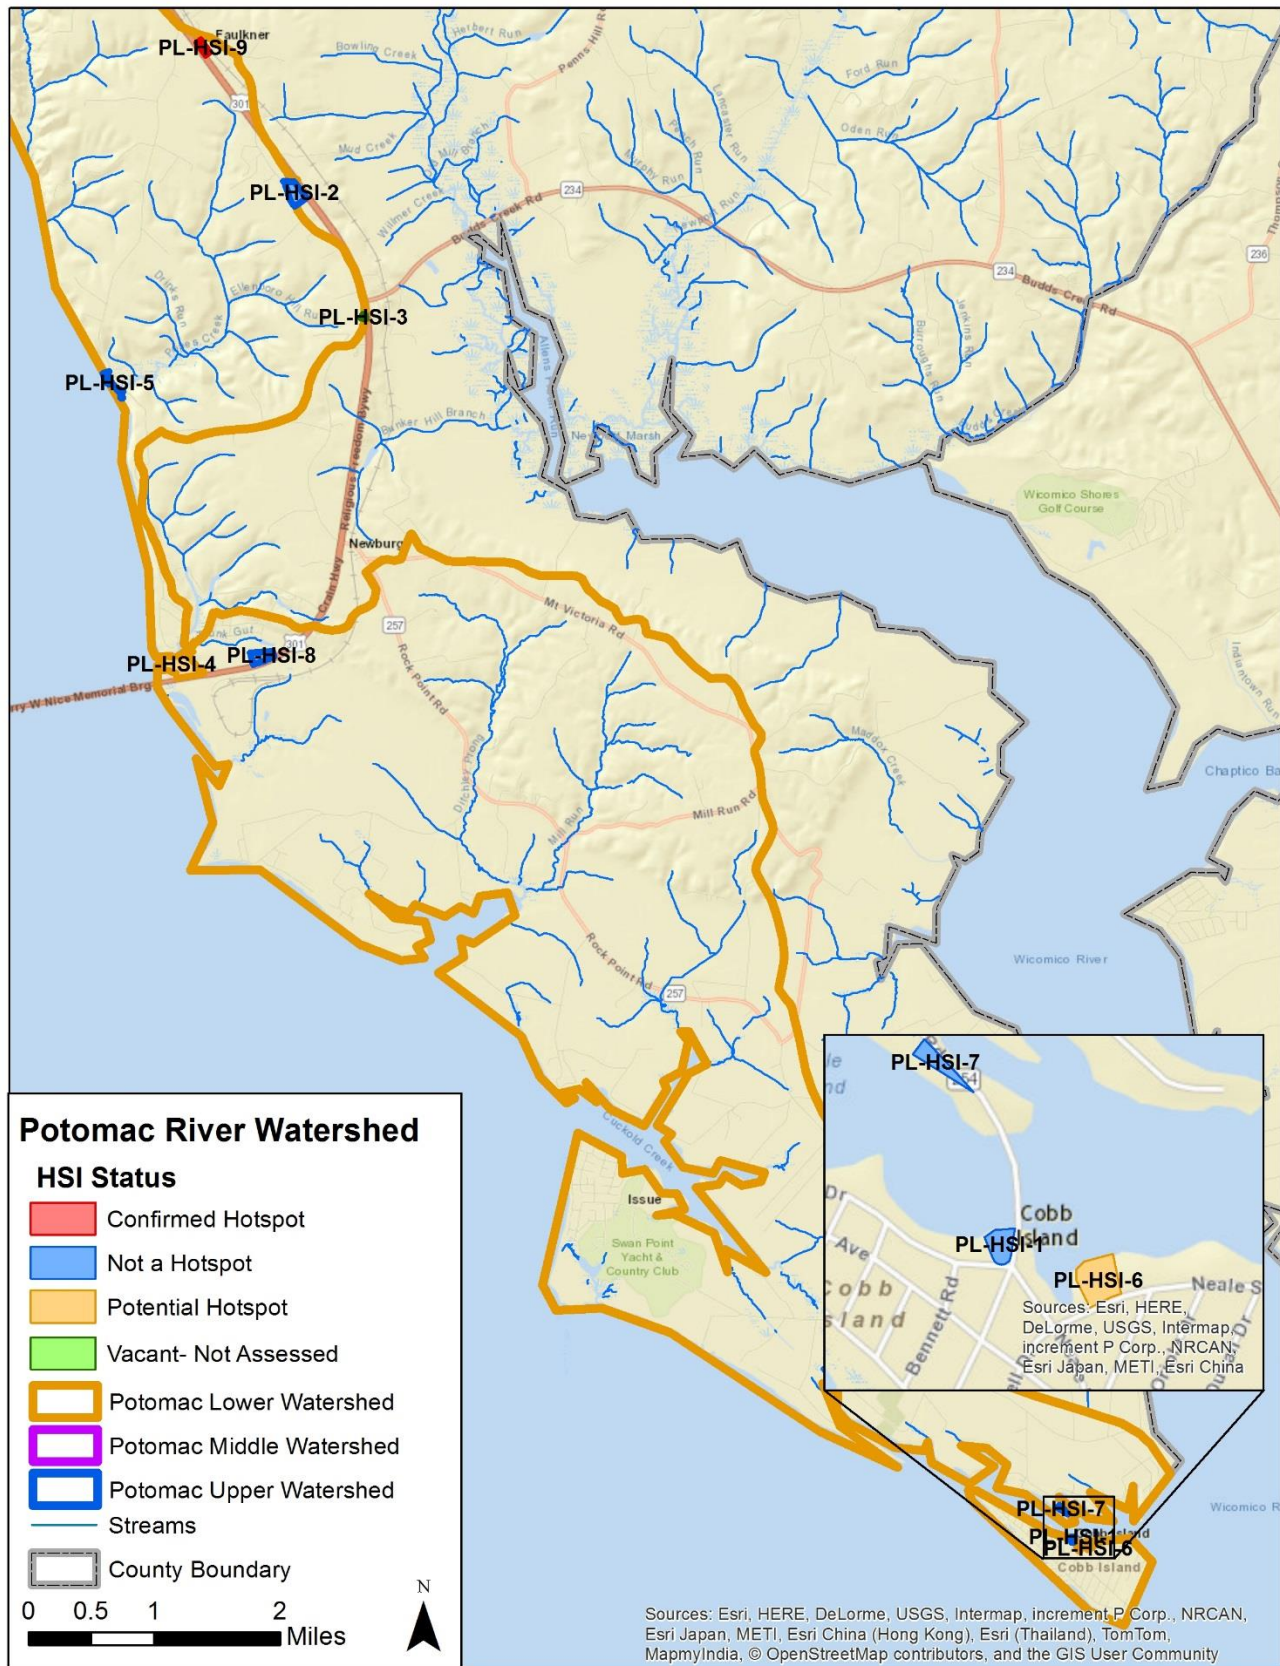
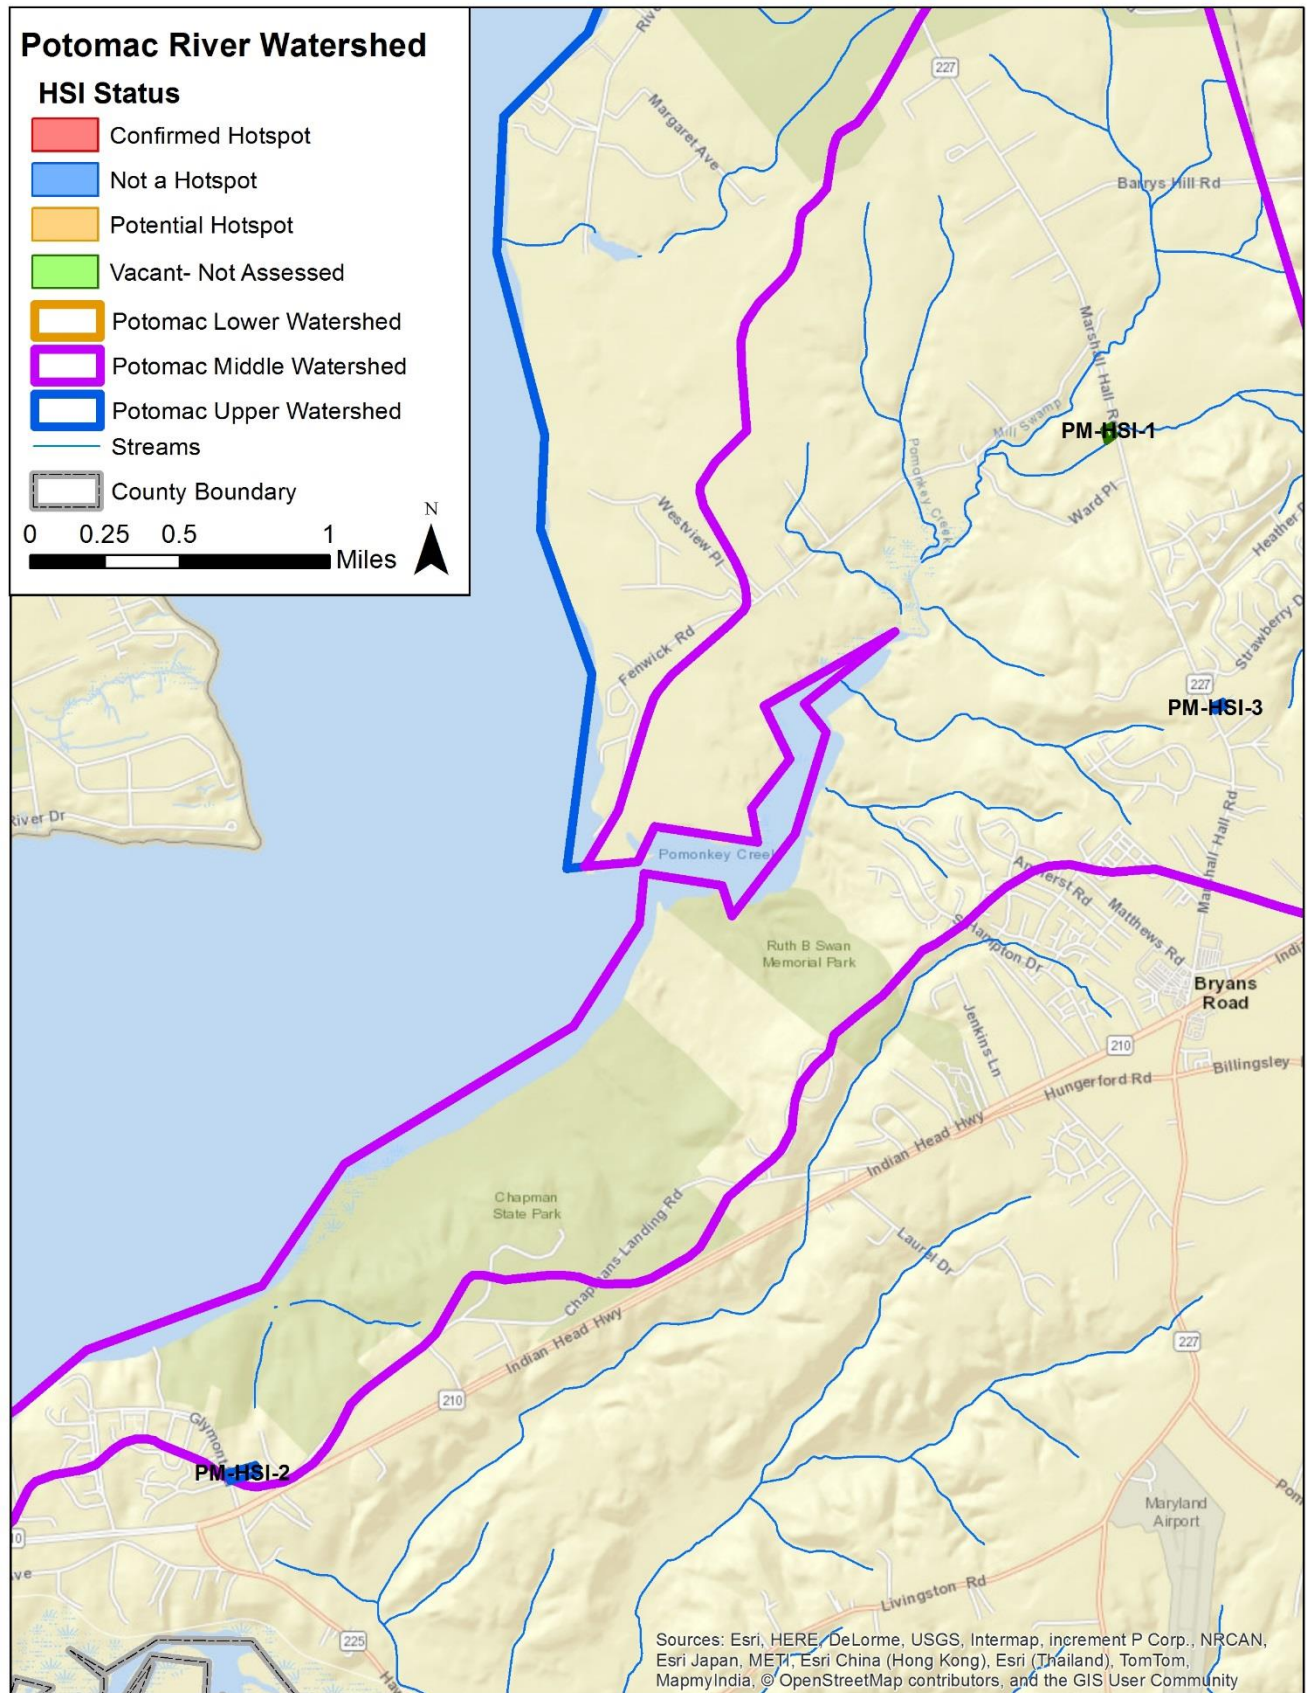
A total of nine sites were investigated in the Potomac Lower watershed and three sites were investigated in the Potomac Middle watershed (Figure 5). No potential hotspot sites were identified in the Potomac Upper watershed. The location, general description, and common operations (i.e., vehicle operations, outdoor materials, waste management, physical plant, turf/landscaping) of each site investigated are presented in Table 6. A complete record of HSI data is included in Appendix B.

Of the twelve sites investigated, only one (PL-HSI-9) site's scoring results designated it as 'confirmed' as having potential for discharging pollutants into stormwater runoff (Table 6), however no serious pollution sources were observed during the site investigation and impervious surfaces at the site were being treated by a infiltration facility at the rear of the property. A total of two locations were designated as 'potential' hotspots, while the remaining seven sites were 'not a hotspot'. Two sites (PL-HSI-3 and PM-HSI-1) were not assessed because they were vacant. It was recommended that five sites be revisited during the stormwater BMP Retrofit Reconnaissance Investigation (RRI) to analyze the site in more detail for BMP opportunities. Specific recommendations for each site can be found in Table 6.

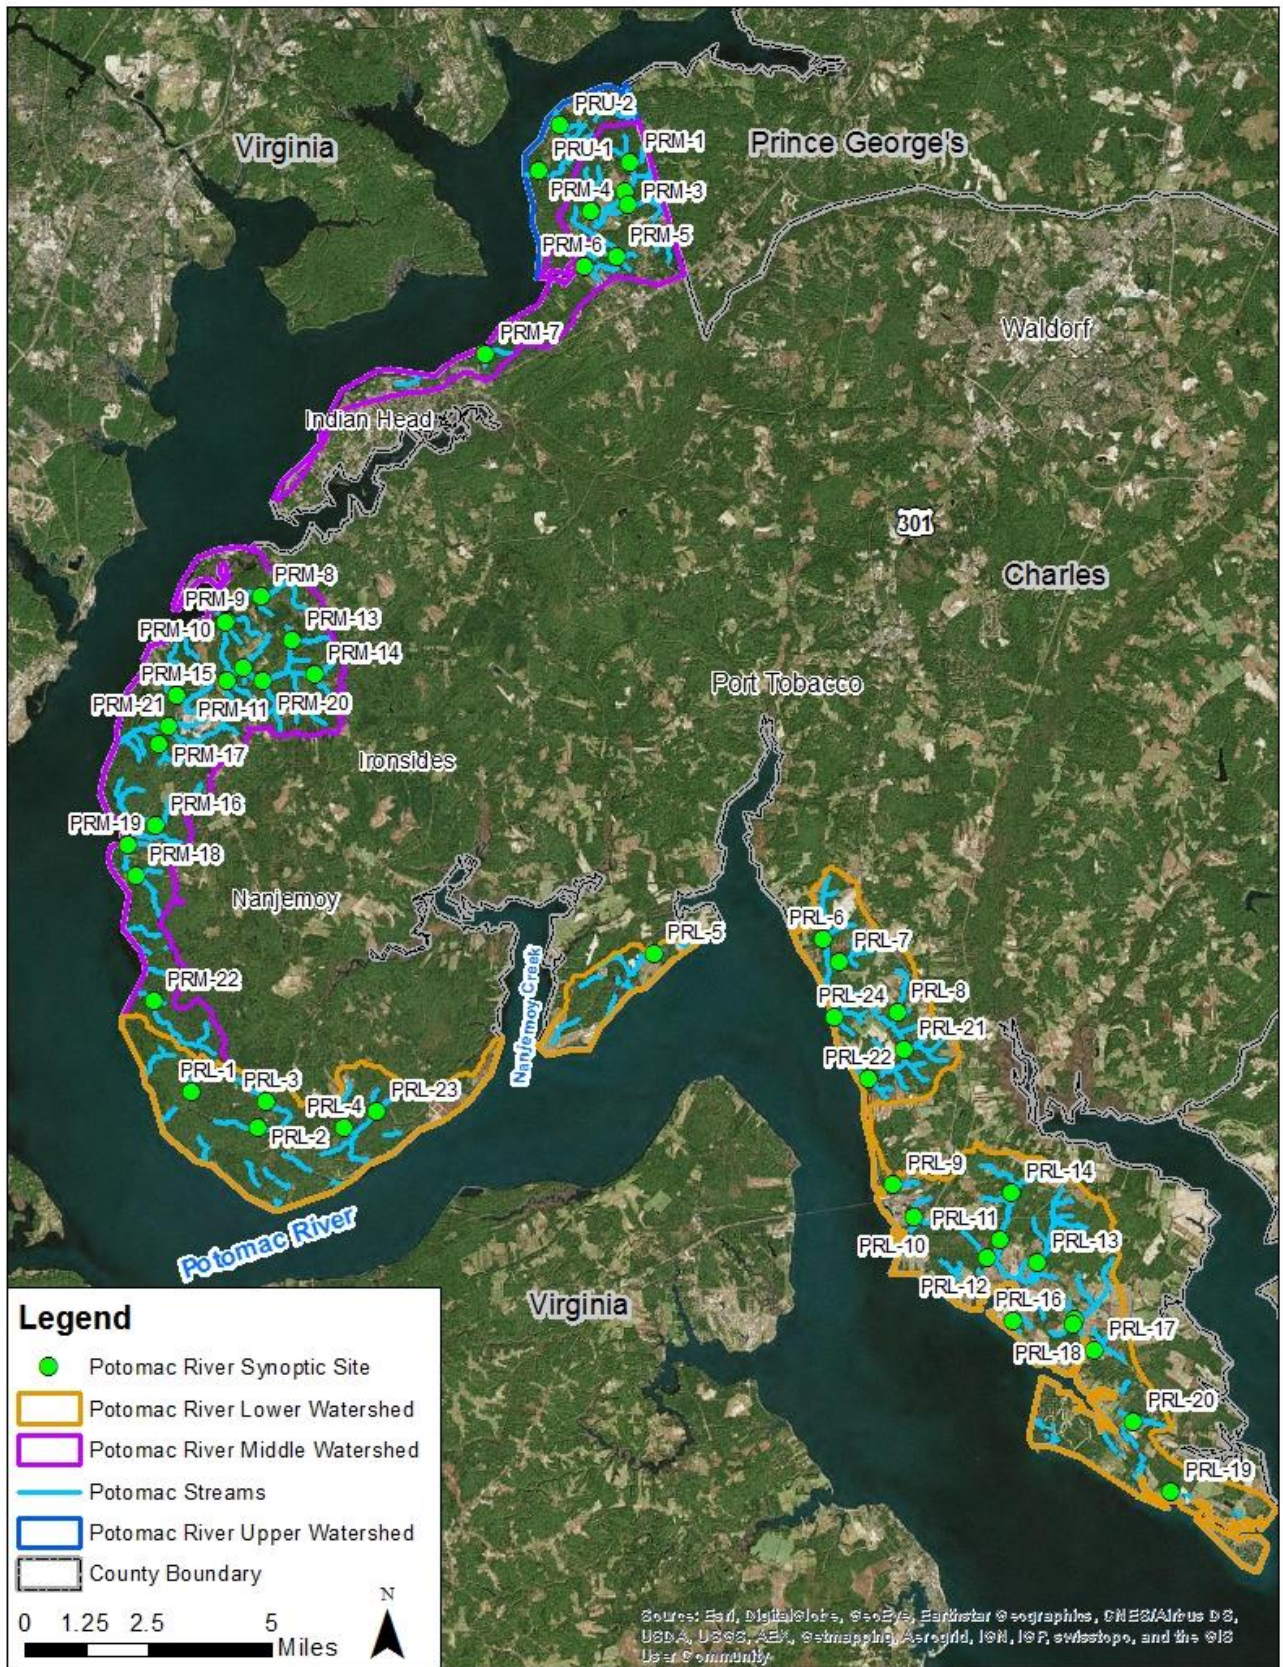
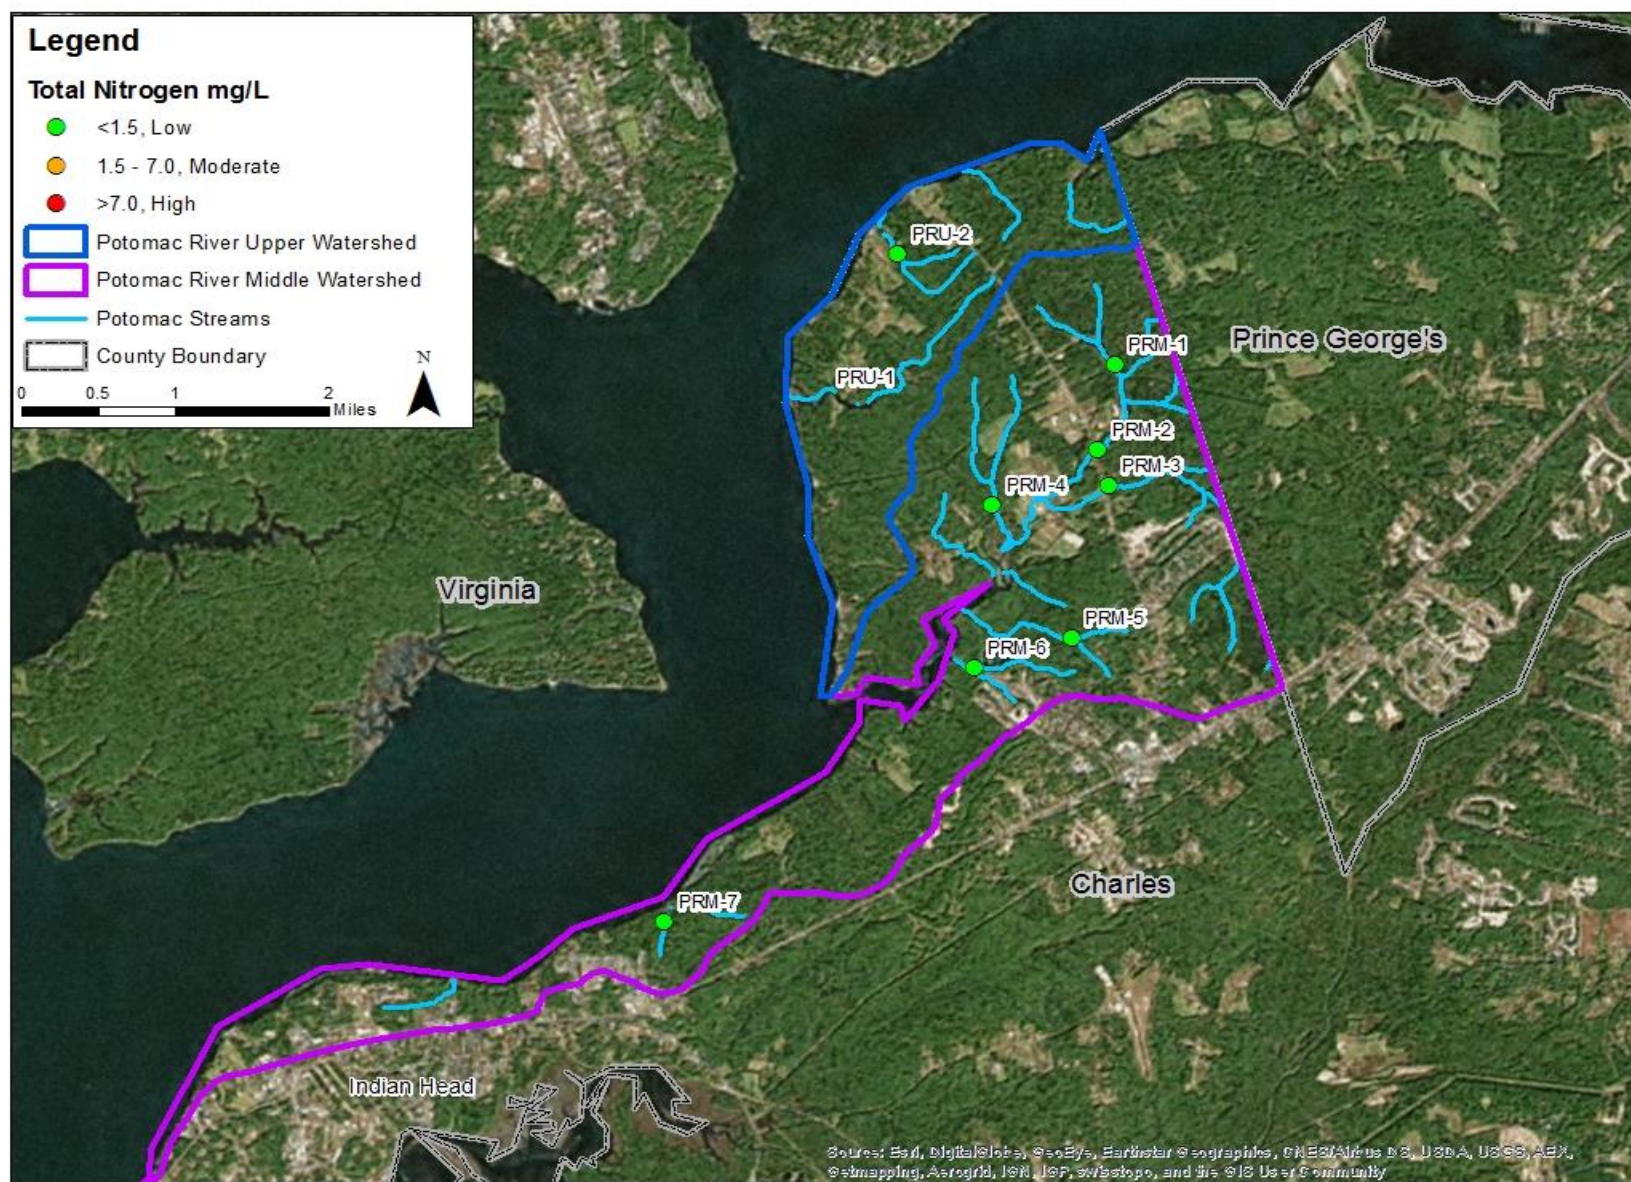
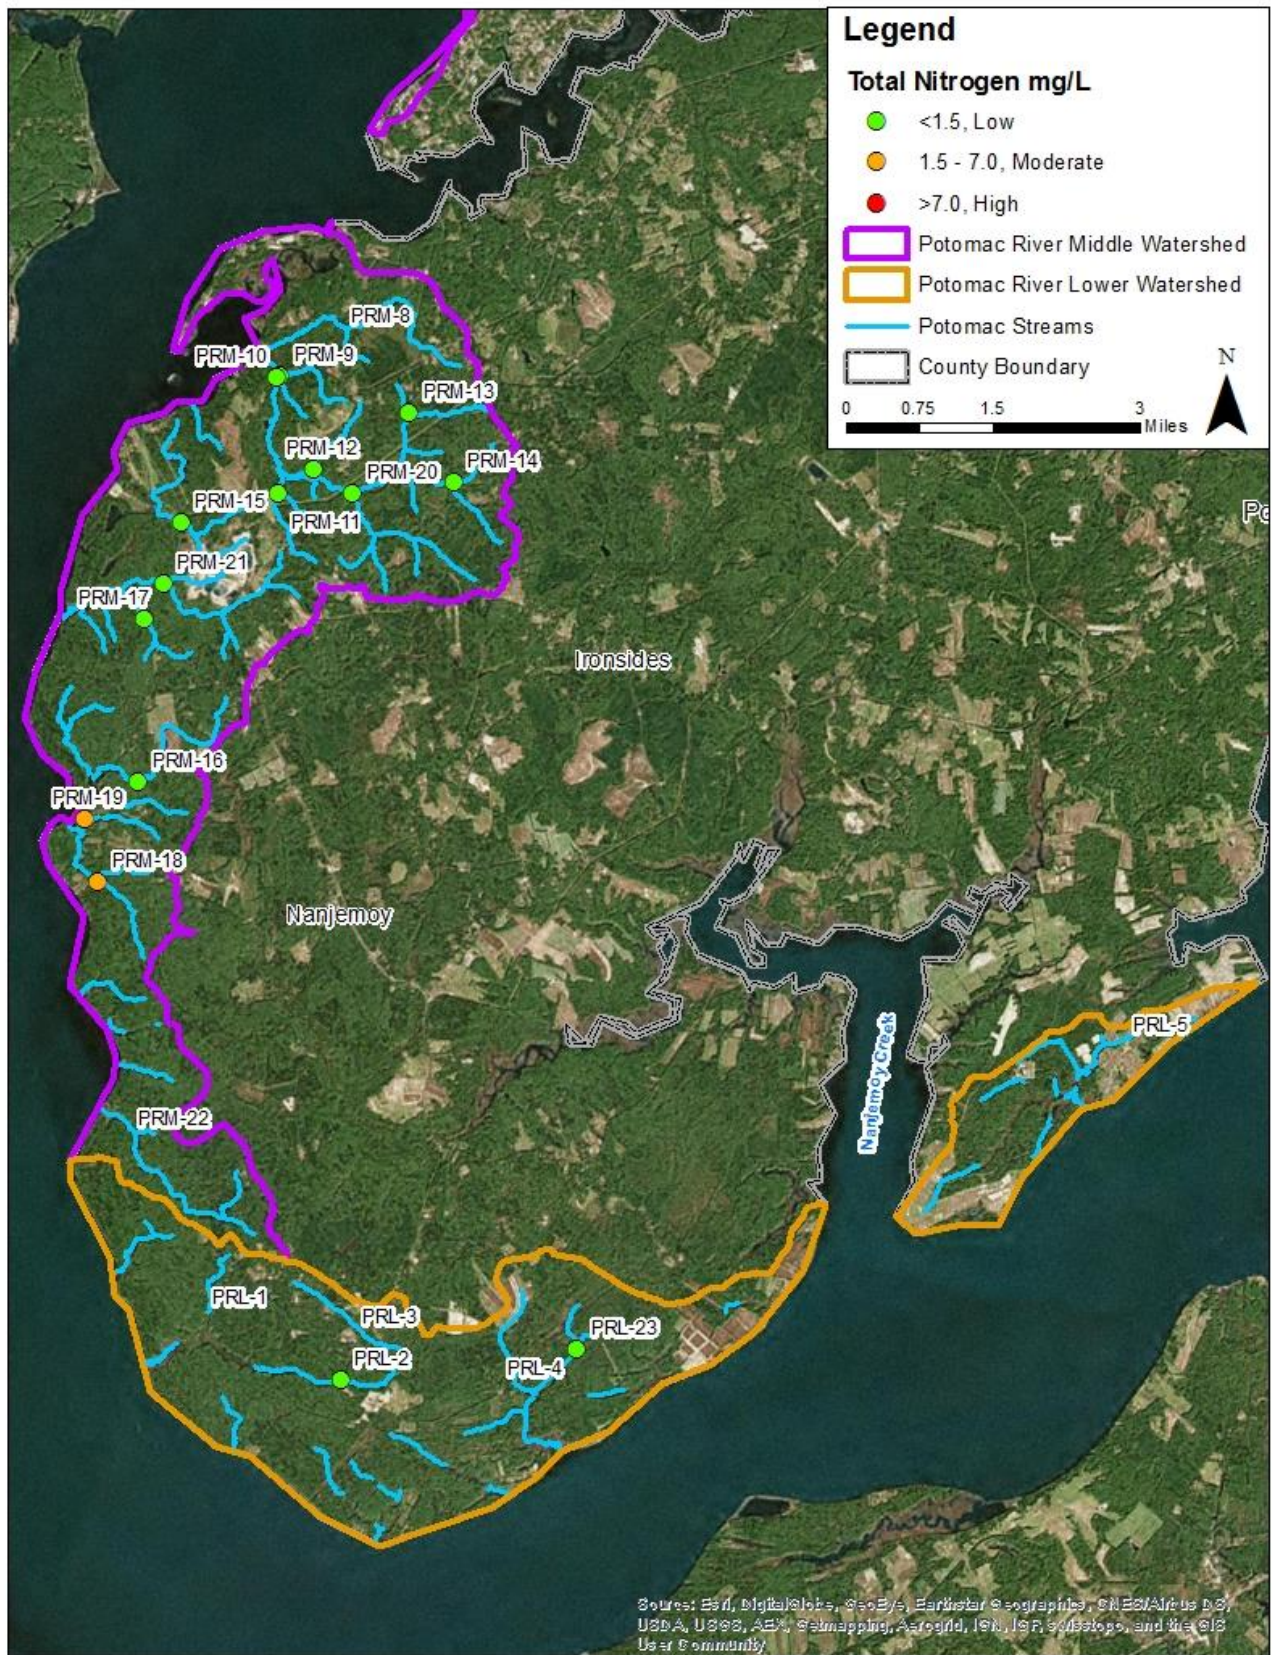
Total nitrogen concentrations were low in Potomac Upper. Two sites had moderate concentrations in the Potomac Middle while only one site was moderate in Potomac Lower. (Figure 8, Figure 9, Figure 10 and Table 10). Within the Potomac Upper, all nitrate/nitrite concentrations were low. One site had moderate concentrations in the Potomac Middle and two sites had moderated levels within two subwatersheds of the Potomac Lower. Baseline conditions were found in the remaining sites (Figure 11, Figure 12, and Table 10). In the Potomac Upper, instantaneous nitrate/nitrite loads were low at all sites. In the Potomac Middle, one site had excessive loads, one site had high loads and three sites had moderate loads. Within the Potomac Lower, only one site had moderate load of nitrate/nitrite while the rest of sites were found to be low (Figure 11, Figure 12, and Table 10). Total phosphorus concentrations in the Potomac Upper were low at all sites. In the Potomac Middle, six sites within two subwatersheds had high concentrations, one site was moderate and the others were low. In the Potomac Lower, six sites had high concentrations in three subwatersheds, five sites were moderate within three subwatersheds and the remaining were low (Figure 14, Figure 15, Figure 16 and Table 10). Within the Potomac Upper, only one site had moderate concentrations of orthophosphate, while in the Potomac Middle, one site was found to be excessive, one site was high and 17 were found to have moderate concentrations. In the Potomac Lower, a total of ten sites had excessive concentrations of orthophosphate within three subwatersheds and three more sites were found to have moderate concentrations (Figure 17, Figure 18, Figure 19 and Table 10). High concentrations were found at one site. Moderate concentrations were found at 30 sites within 12 subwatersheds, however half the detection limit for orthophosphate (0.005) falls between the baseline and moderate ratings, therefore the 31 sites that were below the detection limit should be considered to have baseline levels. Instantaneous orthophosphate loads show no elevated sites within the Potomac Upper, two sites with excessive loads, one with high and four with moderate loads within the Potomac Middle. The Potomac Lower did not have any elevated orthophosphate loads (Figure 17, Figure 18, Figure 19 and Table 10).

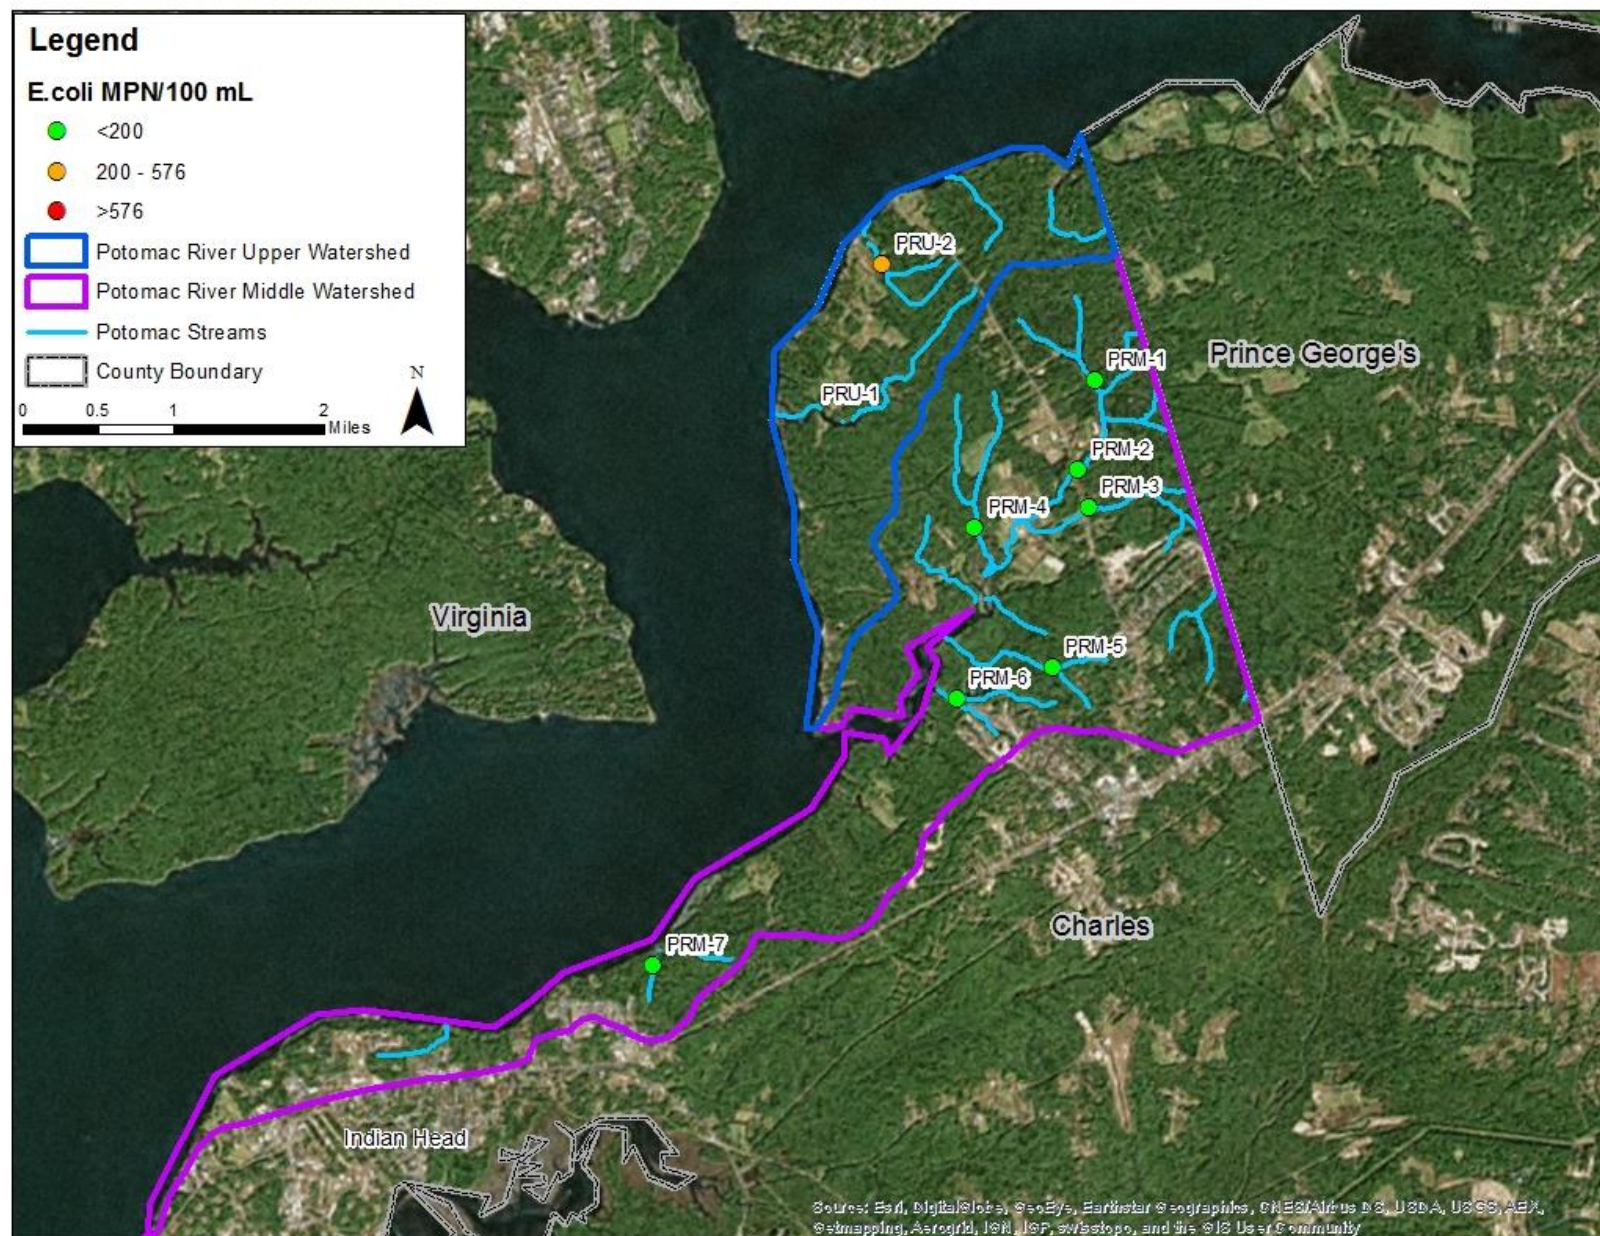
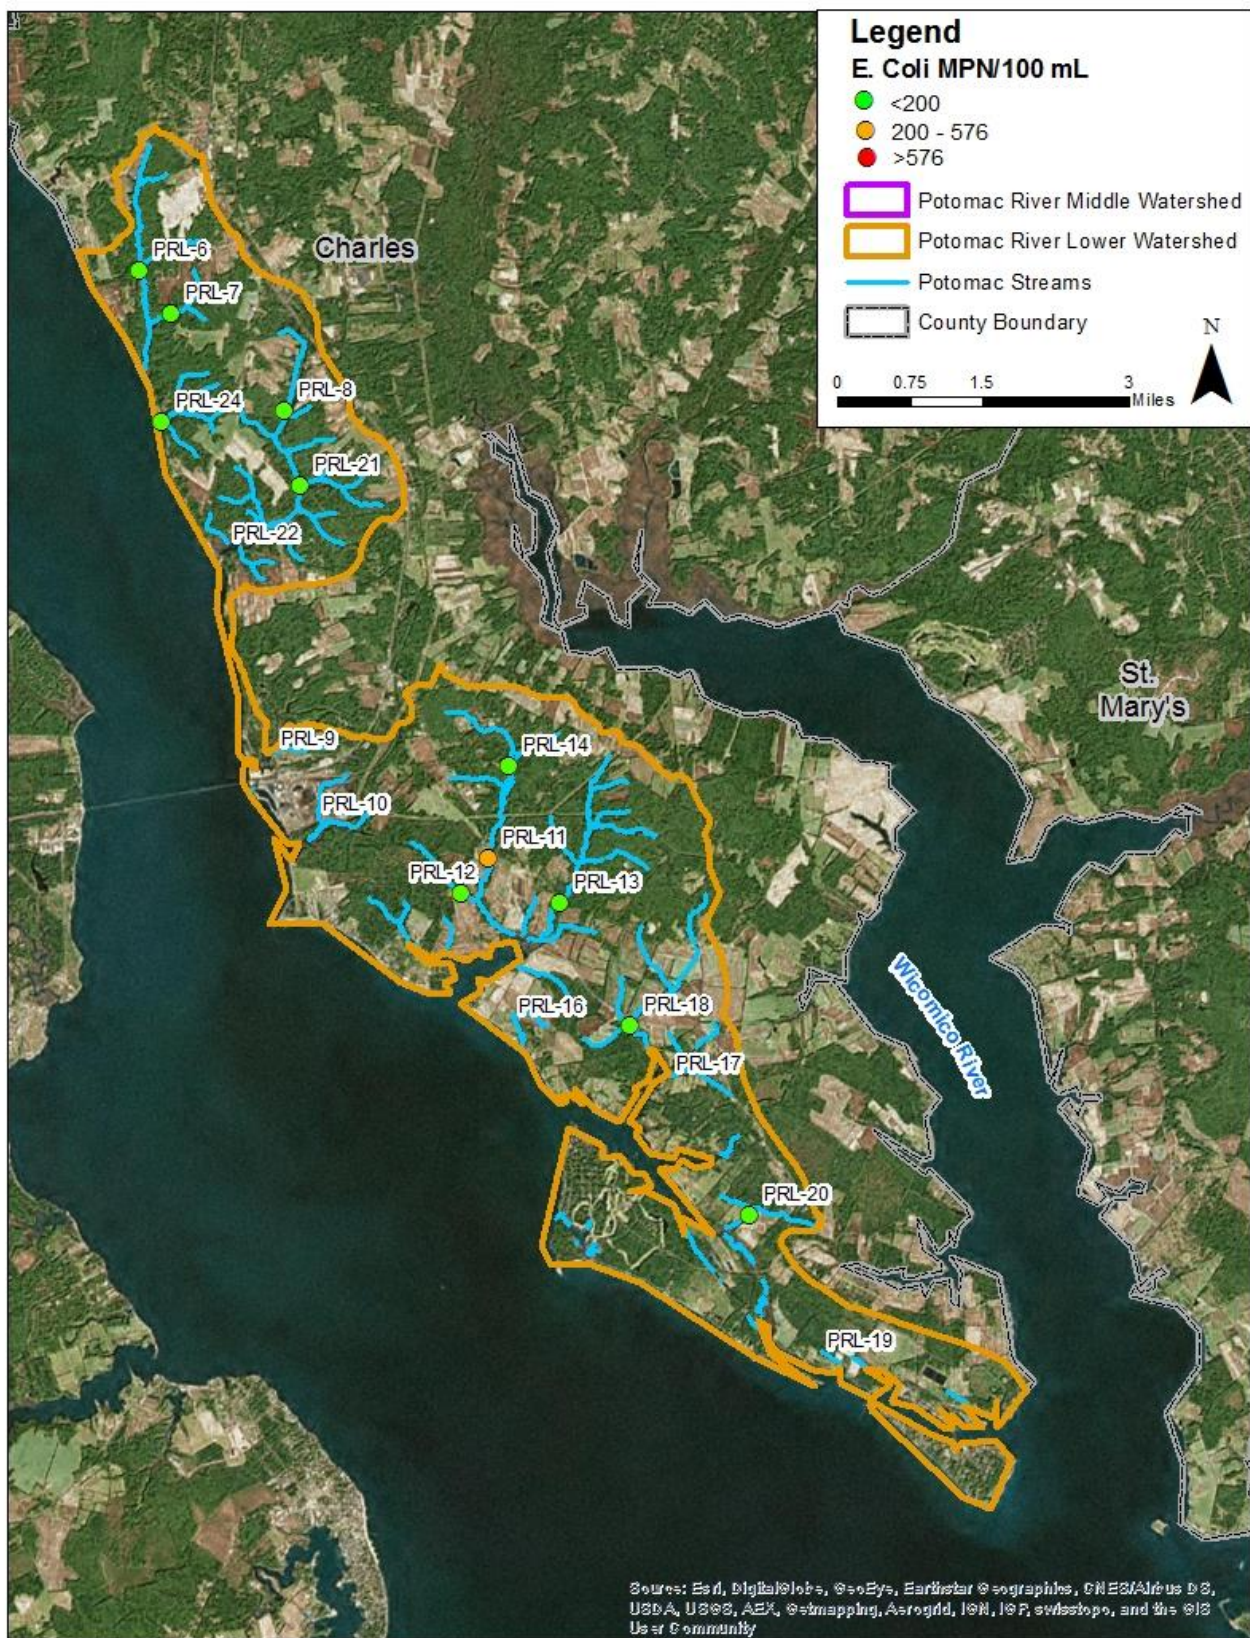
Elevated bacteria levels (*E. coli* > 576 mpn/100 ml; mpn = most probable number) were found at none of the sites within the three watersheds, while one site in Potomac Middle and one site in Potomac Lower, had levels exceeding the standard for water contact recreation of 200 mpn/100 ml (Figure 20, Figure 21, Figure 22 and Table 10).

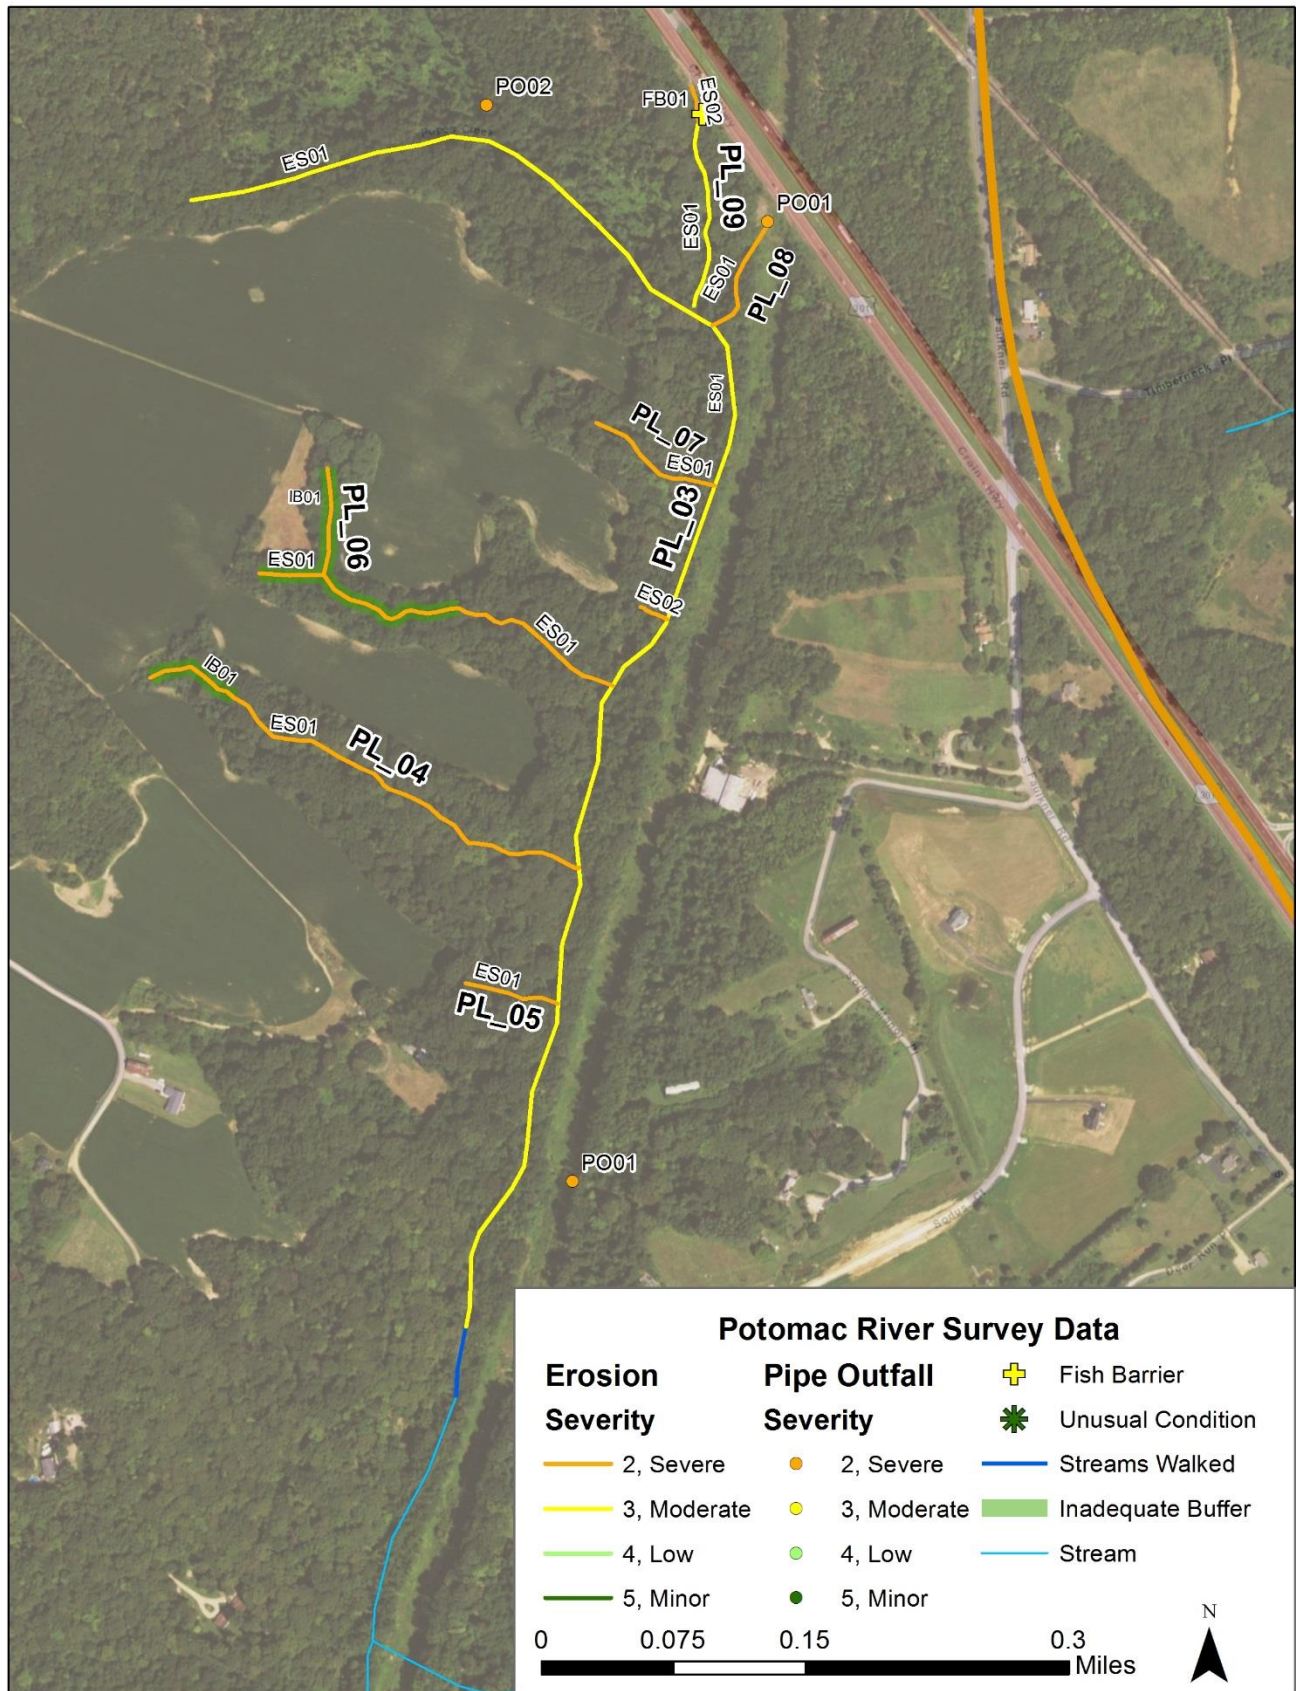
FIGURE 32. SURVEY DATA MAP SHOWING PIPE OUTFALL, EROSION, FISH BARRIER, AND INADEQUATE BUFFER SITES, POTOMAC LOWER, NORTHEASTERN PORTION

Only one fish barrier was observed during the survey. The barrier was associated with the downstream side of a road crossing pipe culvert. The culvert was elevated approximately 36 inches from the downstream pool and received a severity rating of 'moderate'. The location and severity of the fish barrier is displayed in Figure 32.
