# UPPER, MIDDLE, AND LOWER POTOMAC RIVER

## WATERSHED ASSESSMENT

MAY | 2018

KCI TECHNOLOGIES, INC.  
936 RIDGEBROOK ROAD  
SPARKS, MD 21152

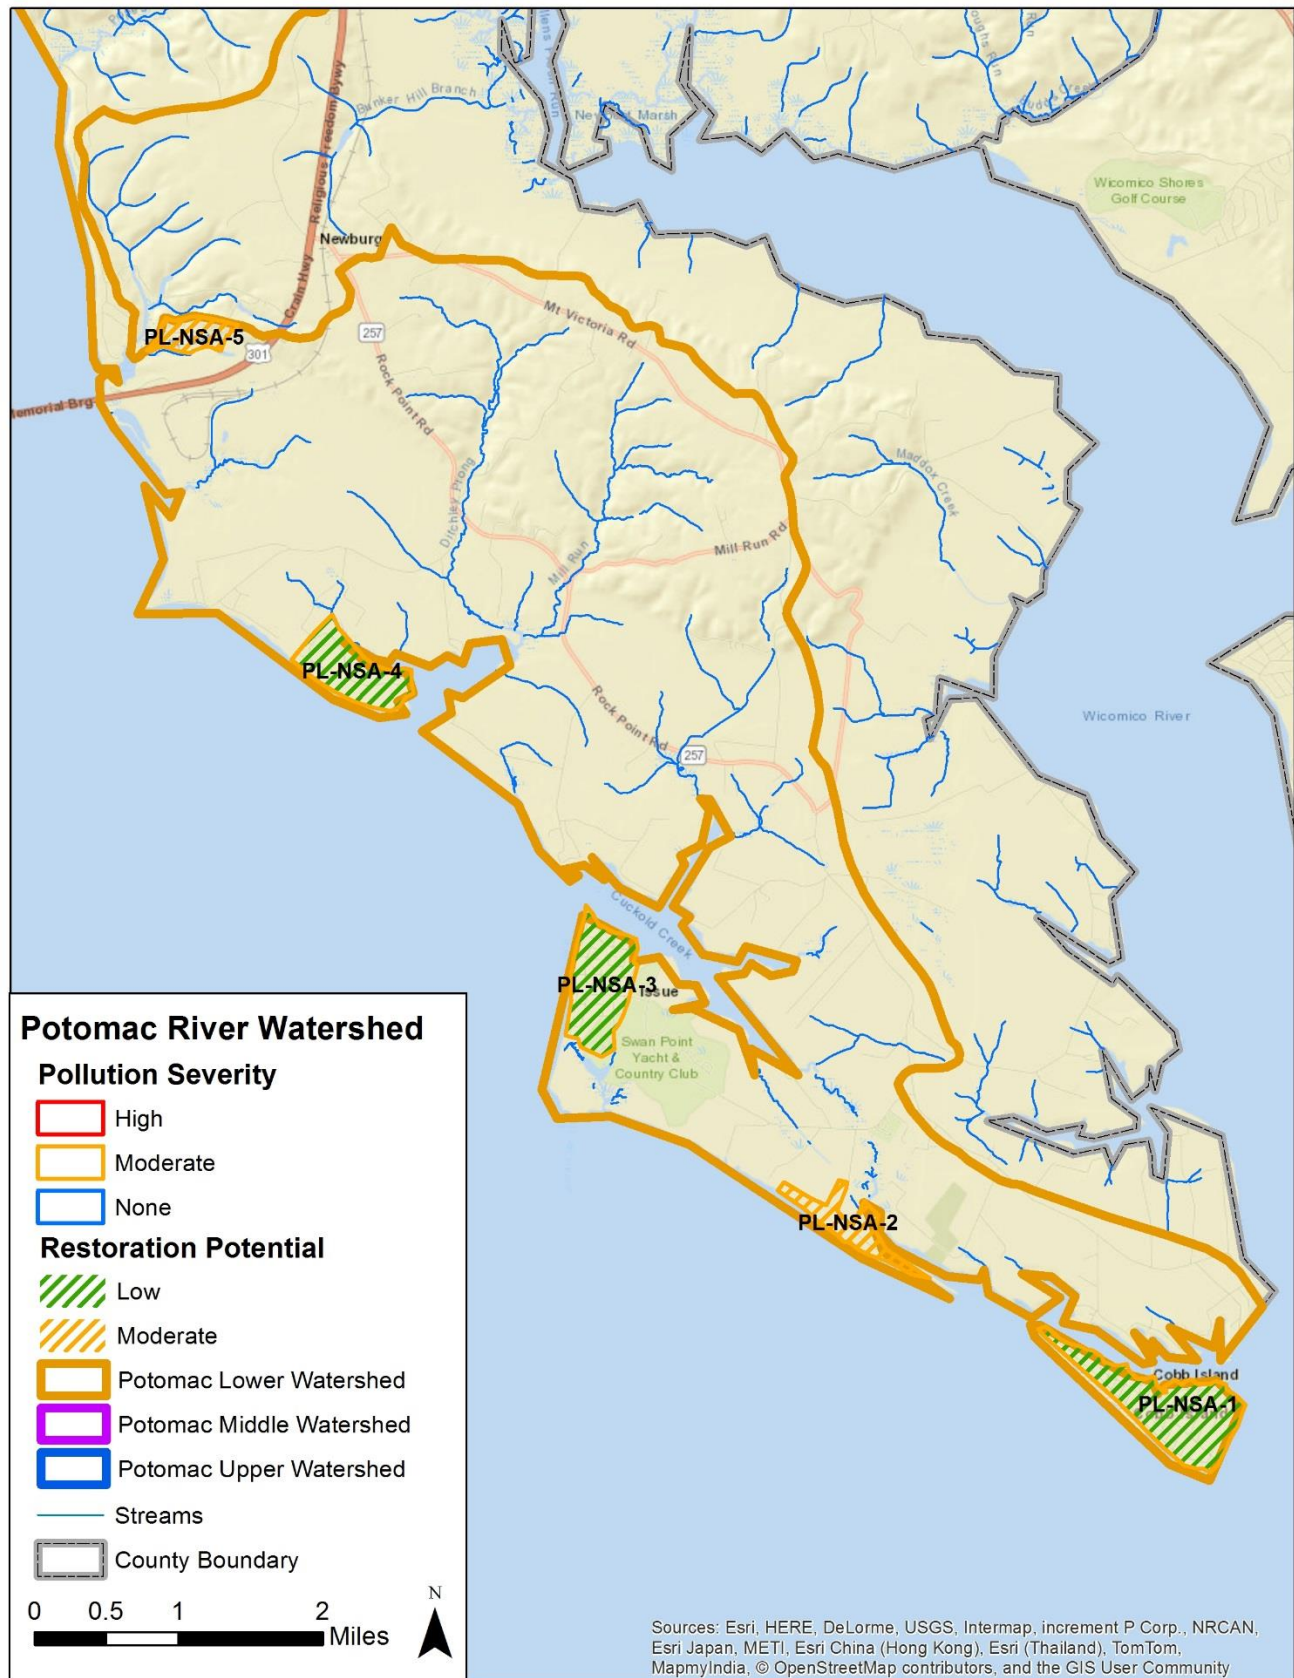
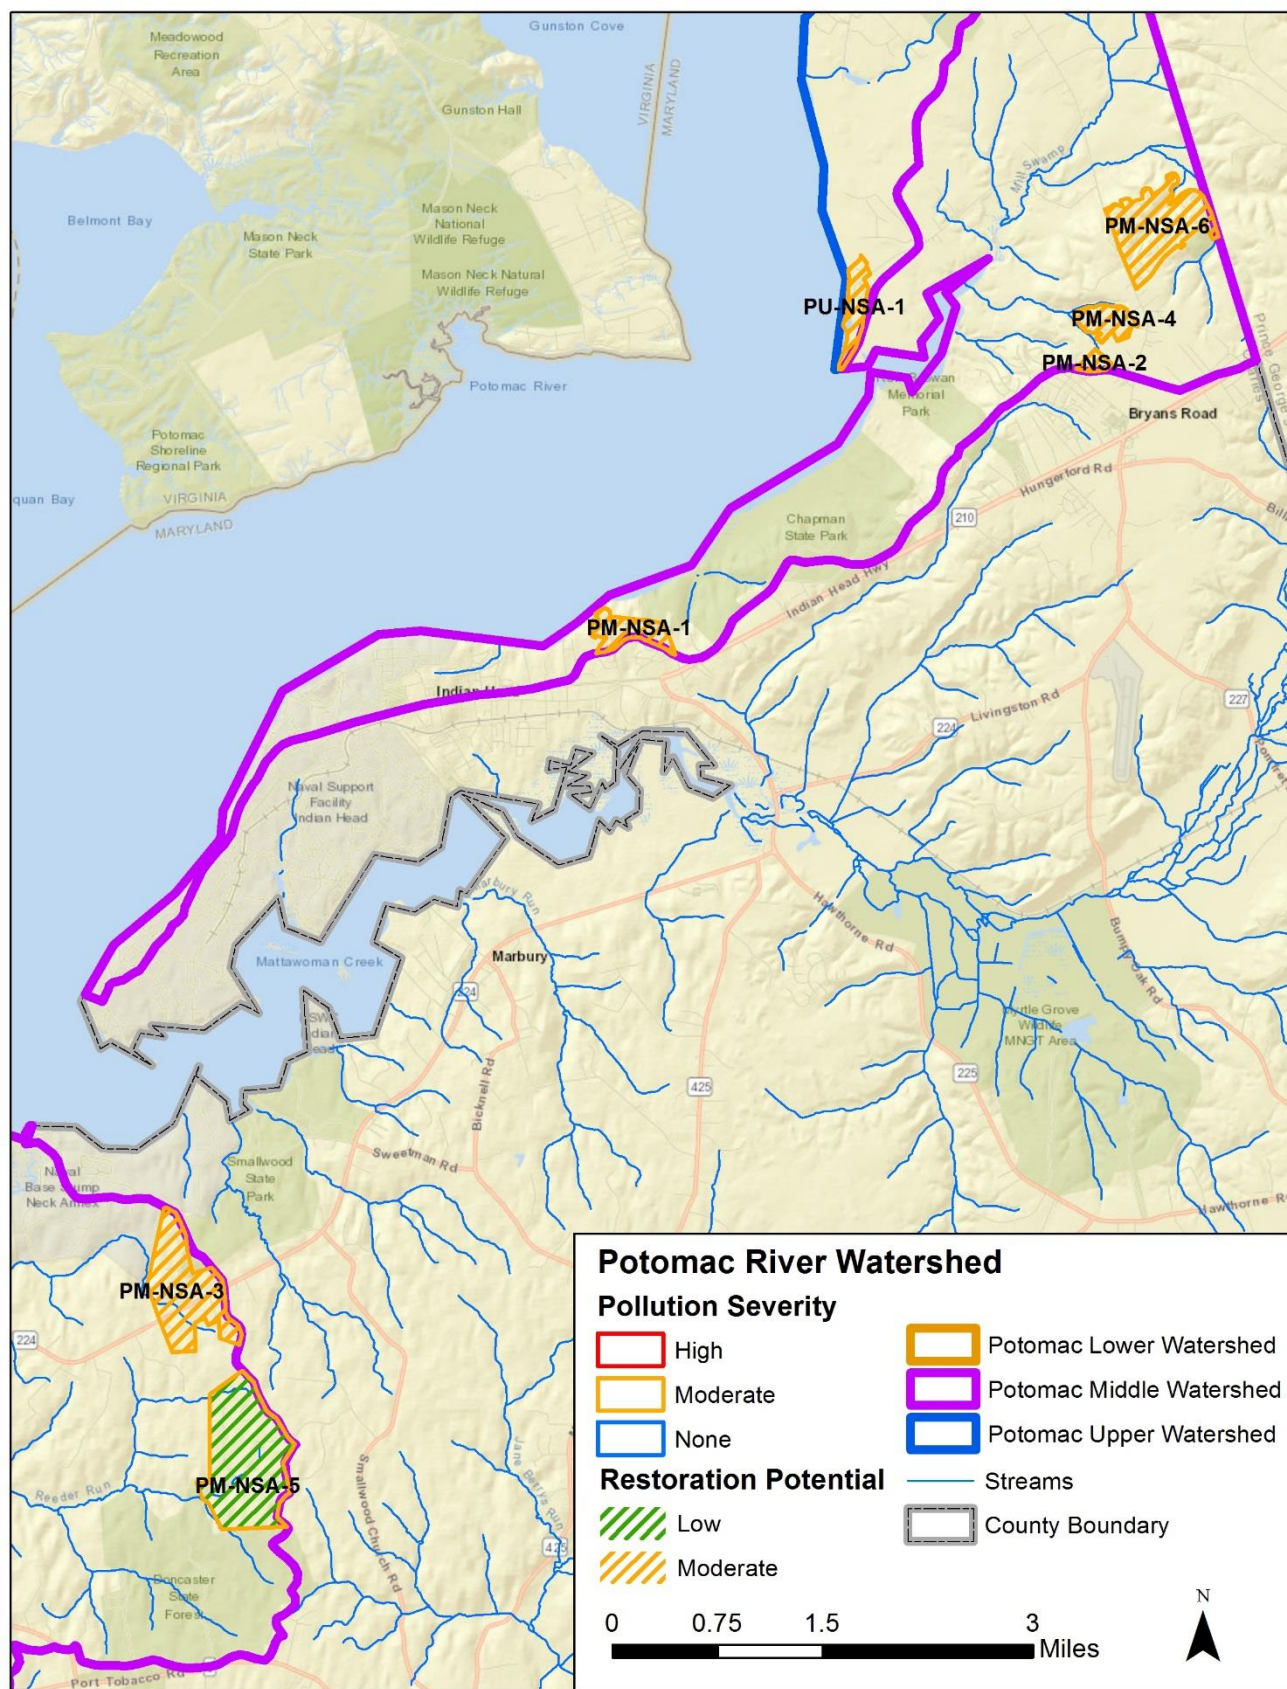
A total of twelve neighborhoods were assessed in the Potomac River watershed (Figure 3). General characteristics of each neighborhood are presented in Table 4. A complete record of NSA data is included in Appendix A.

The neighborhoods in these watershed are generally very rural and spread out. All of the twelve neighborhoods assessed received a 'moderate' pollution severity rating. Potential pollution types included nutrient and bacteria (Table 5).

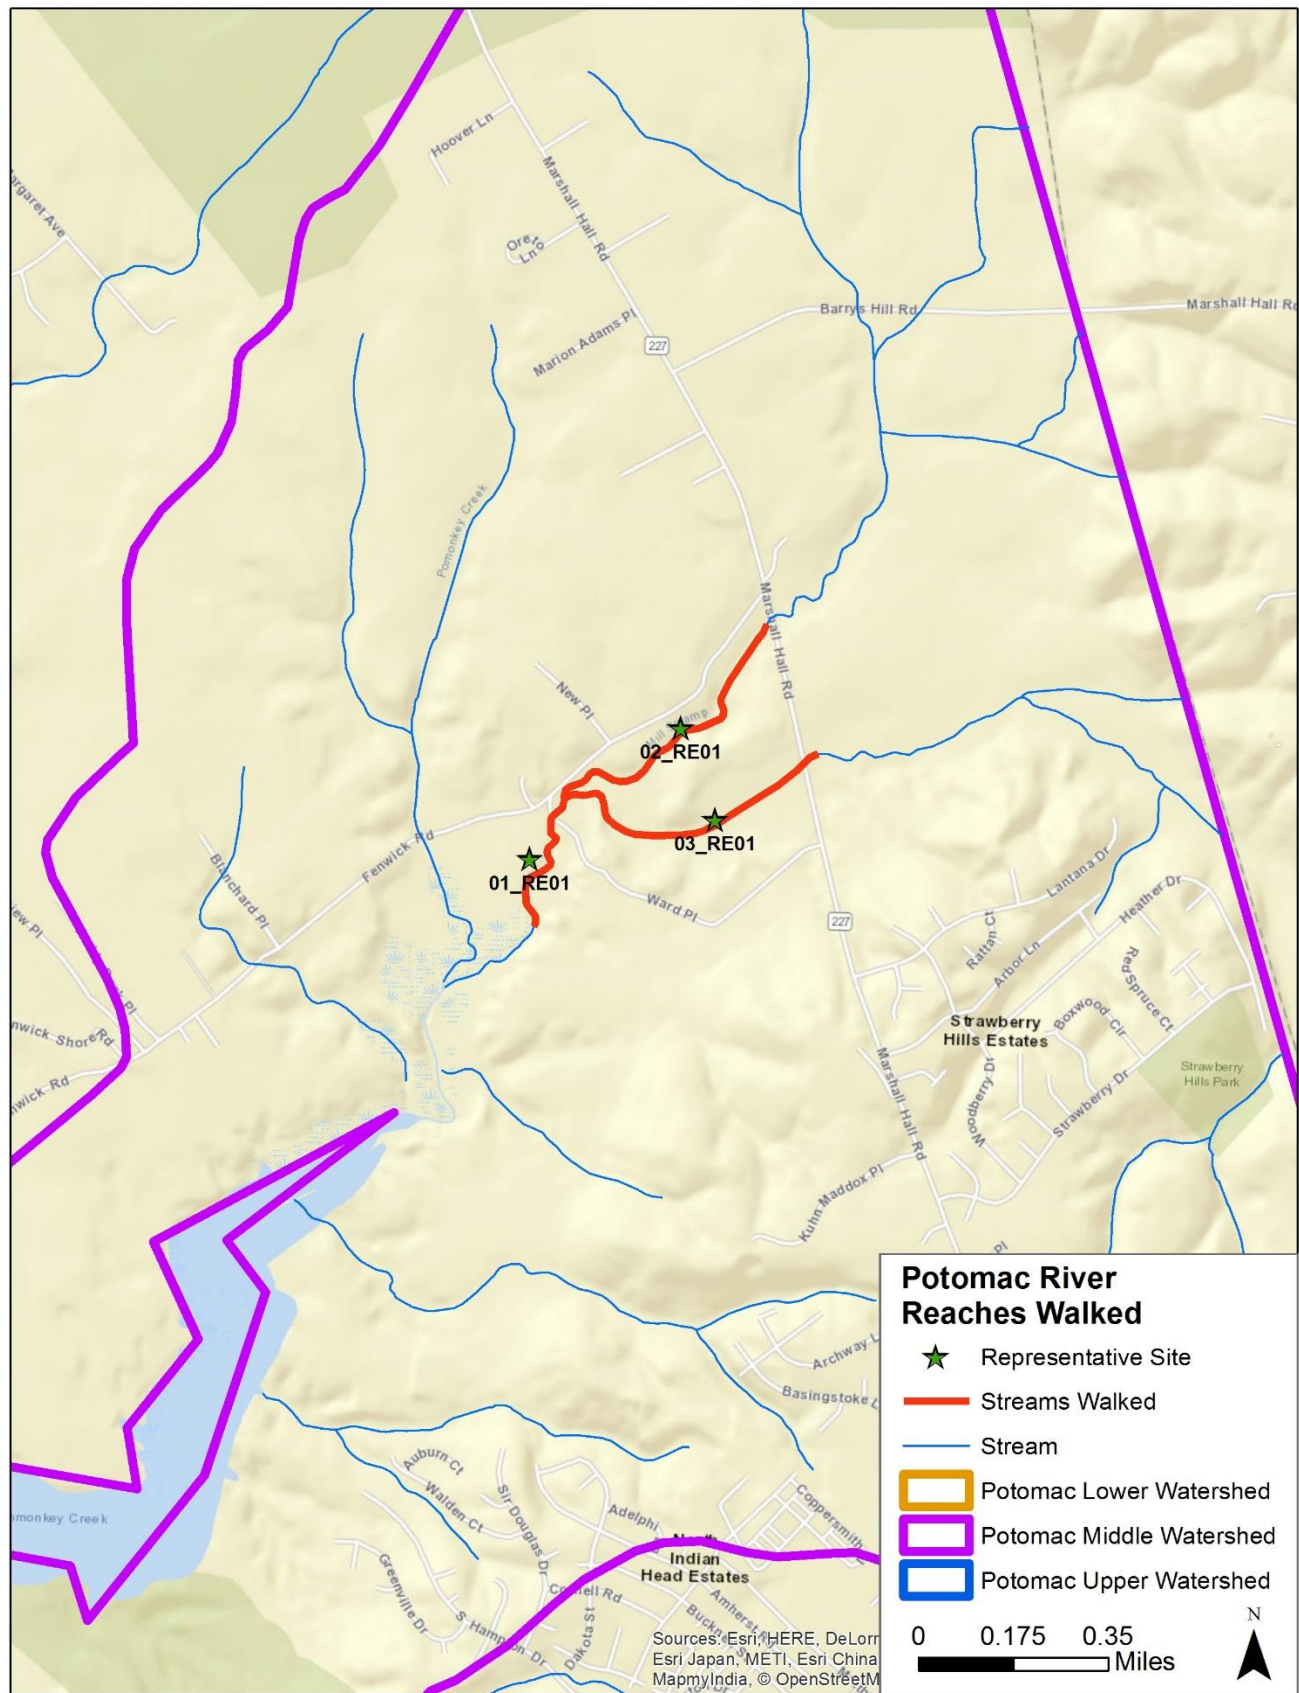
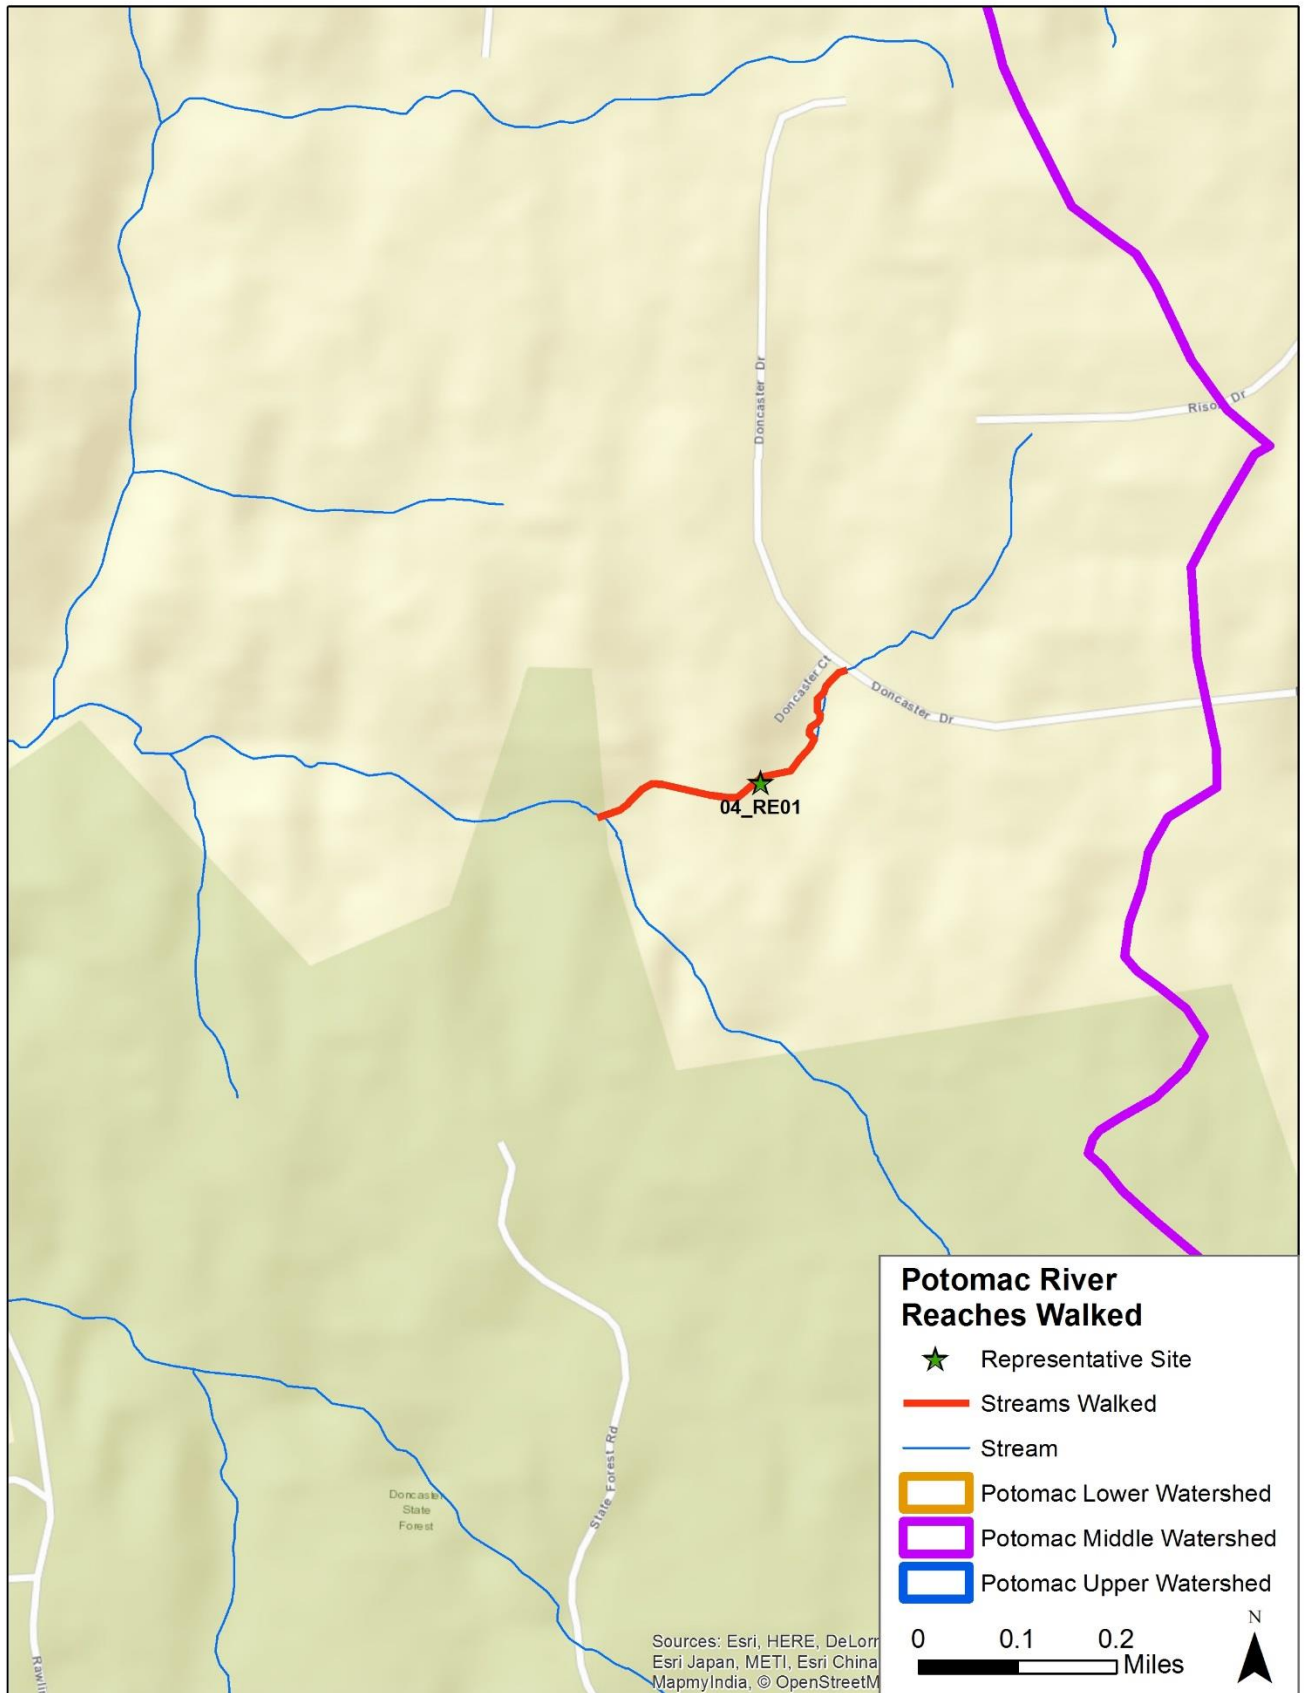
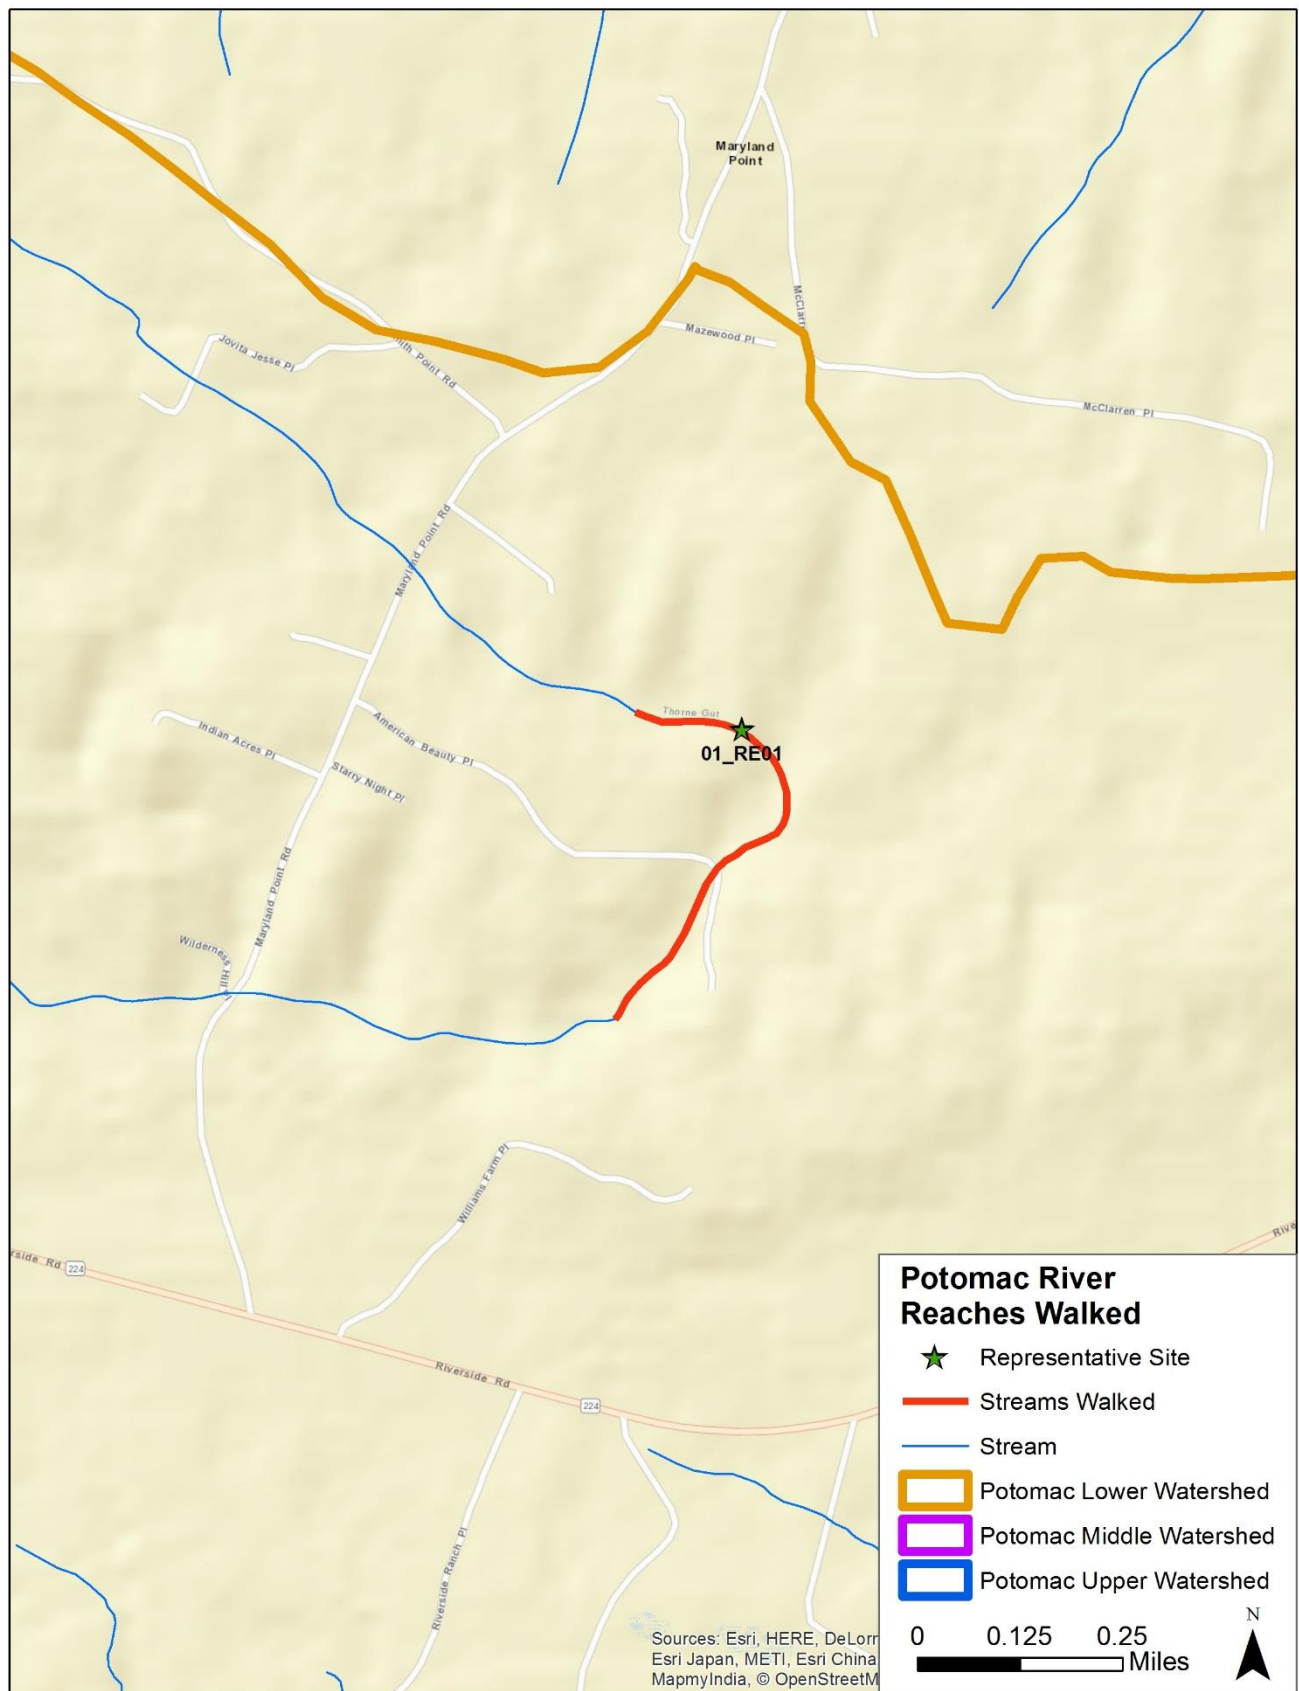
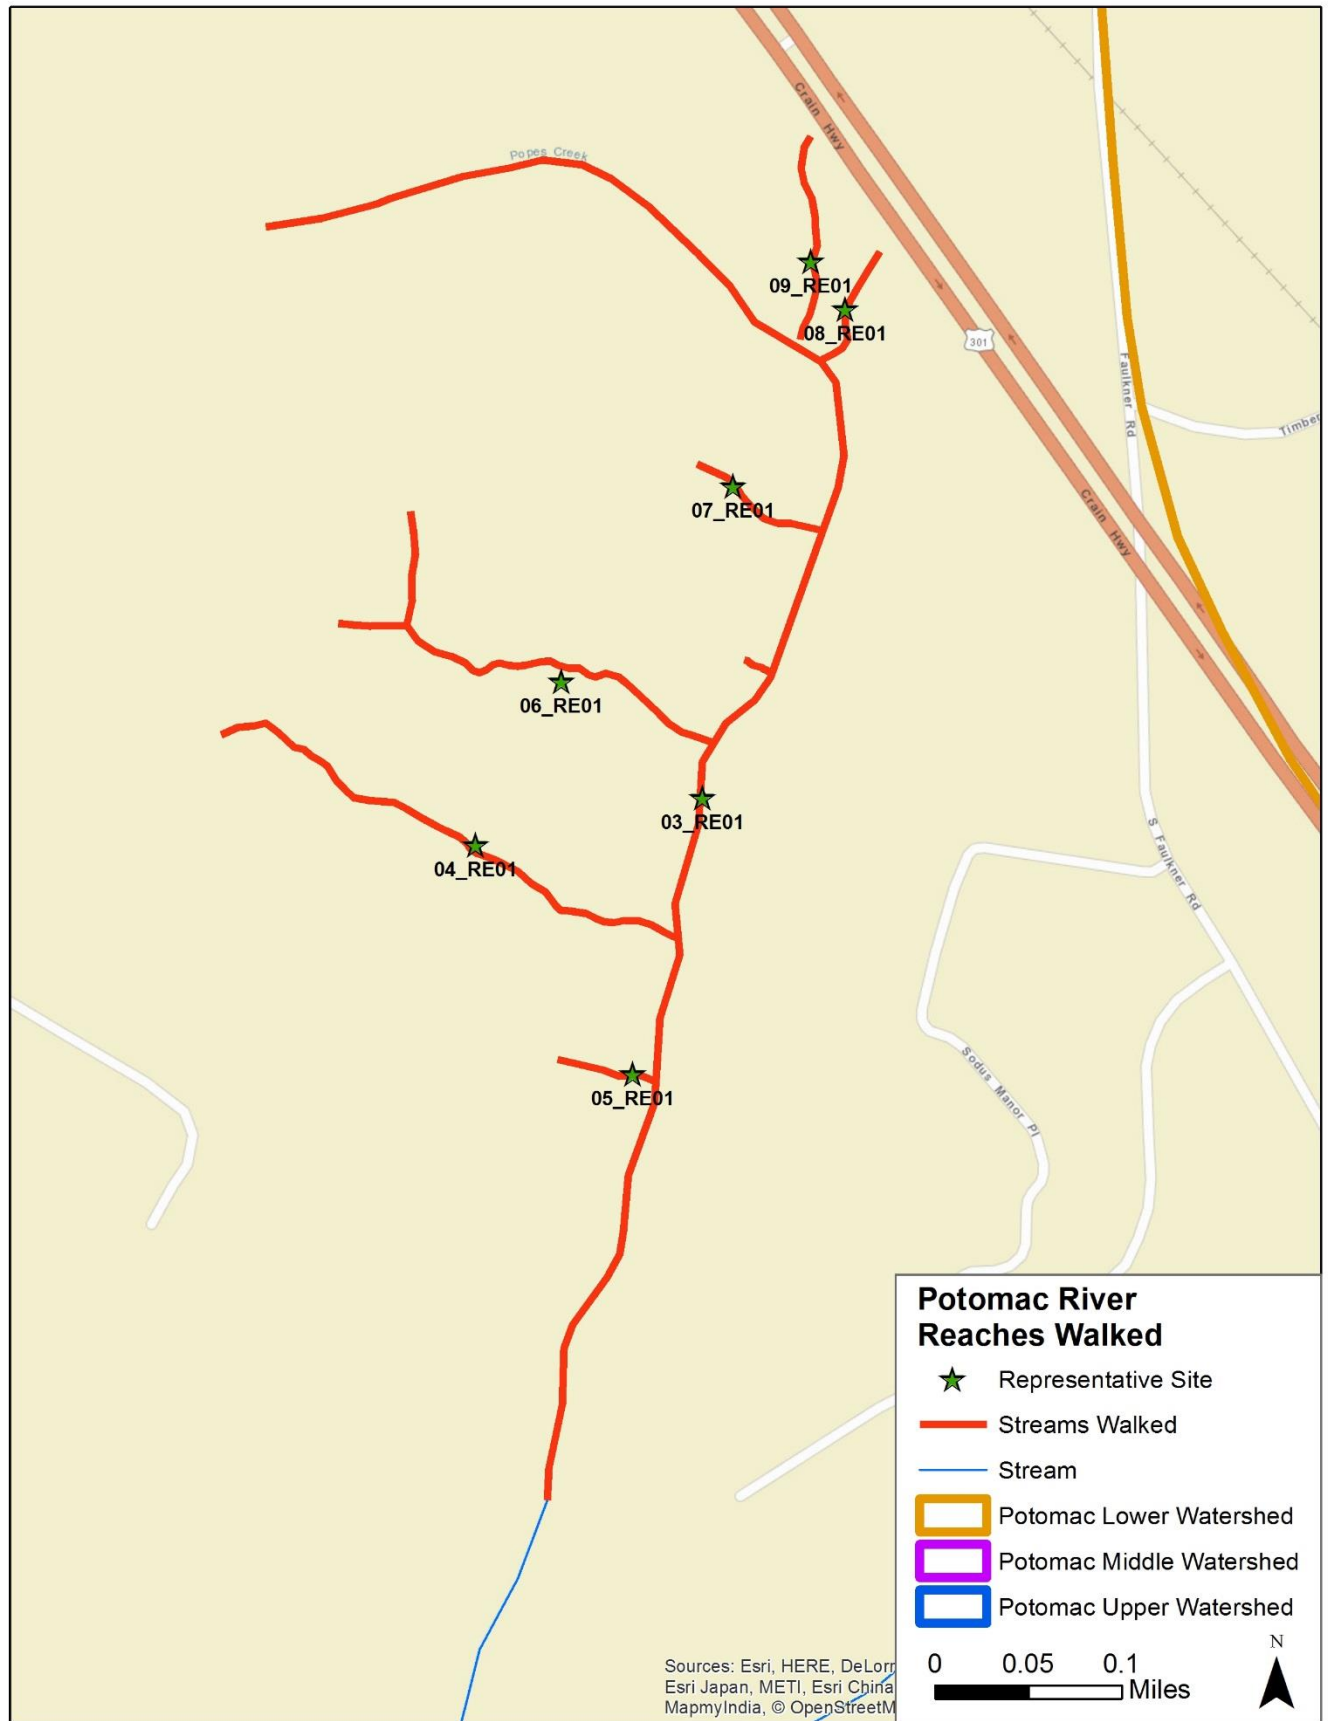
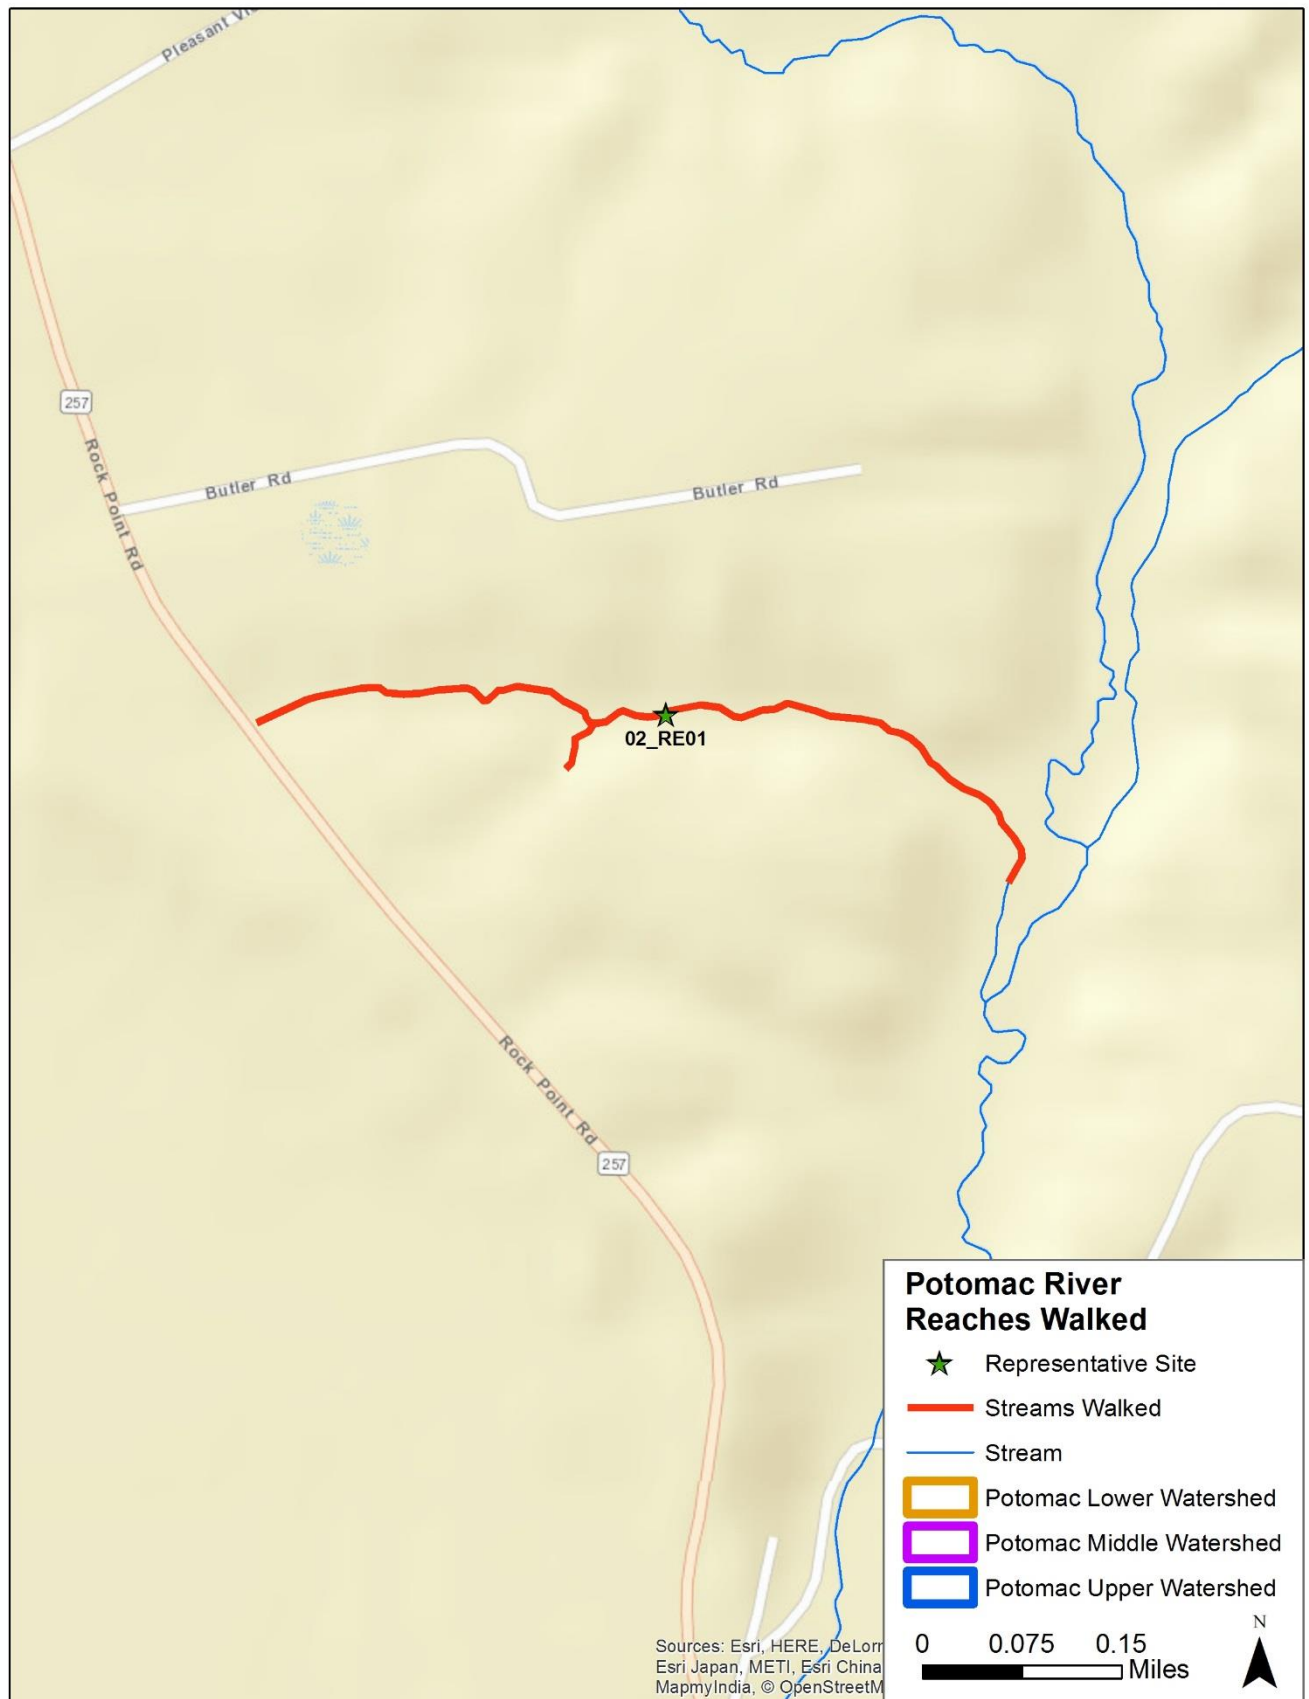
Representative points were taken at 13 locations (Figure 23 through Figure 27). Figure 28, below, presents the proportion of reaches in each assessment category for each habitat parameter, giving insight into the types of stream impacts creating the most degradation. In general, the modified qualitative RBP assessment at these sites revealed stream channels dominated by clay, silt, sand and gravel substrates. There were a wide range of scores for riparian vegetation and sediment deposition, ranging from 'poor' to 'optimal', with most of the sites falling within the 'suboptimal' range. Bank condition ranged from 'poor' to 'suboptimal' while bank vegetation ranged from 'poor' to 'optimal'. A majority of sites received a 'suboptimal' score for channel flow status, with scores ranging from 'marginal' to 'optimal'. Velocity depth diversity scores primarily fell within the 'marginal' category, with a few sites within the 'poor' and 'suboptimal' range. The vast majority of sites were unaltered and as a result, most scores for channel alteration fell within the 'optimal' range. Embeddedness, shelter for fish, and benthic substrate scores ranged from 'poor' to 'suboptimal', with most scores within the 'poor' and 'marginal' range.

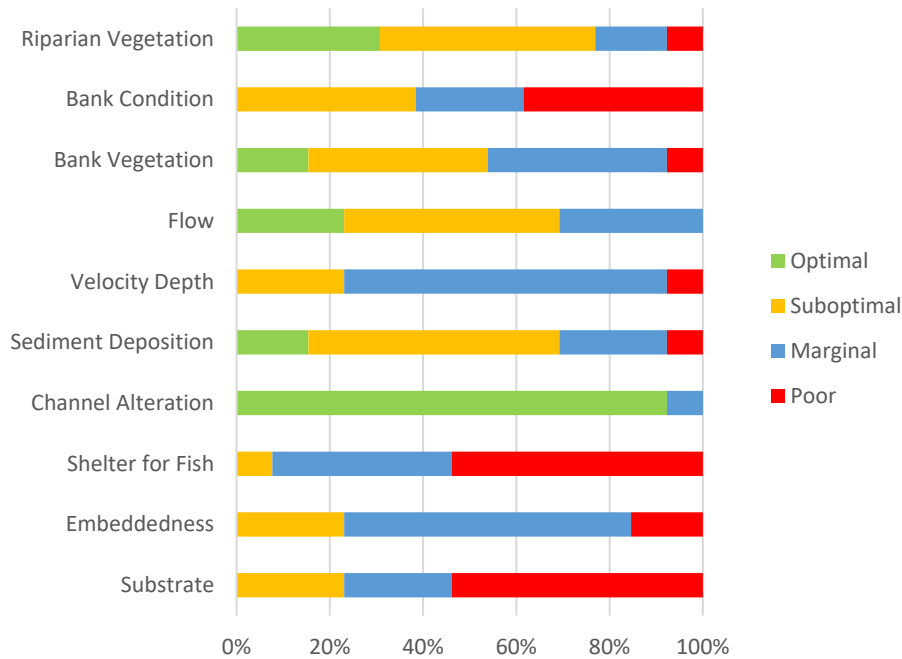
FIGURE 28: PROPORTION OF REACHES PER ASSESSMENT CATEGORY

Stream channel erosion is a major factor leading to impaired habitat conditions. Approximately 78% of the total length of streams walked were considered eroded. Widening, headcutting, and downcutting were the erosion processes identified. As the stream channels widen and become incised, the ability to effectively transport sediments (eroded bank material and from runoff over land) is reduced, leading to reduced scores for several habitat parameters including flow, velocity, embeddedness and macroinvertebrate habitat.
