# UPPER, MIDDLE, AND LOWER POTOMAC RIVER

## WATERSHED ASSESSMENT

MAY | 2018

KCI TECHNOLOGIES, INC.  
936 RIDGEBROOK ROAD  
SPARKS, MD 21152

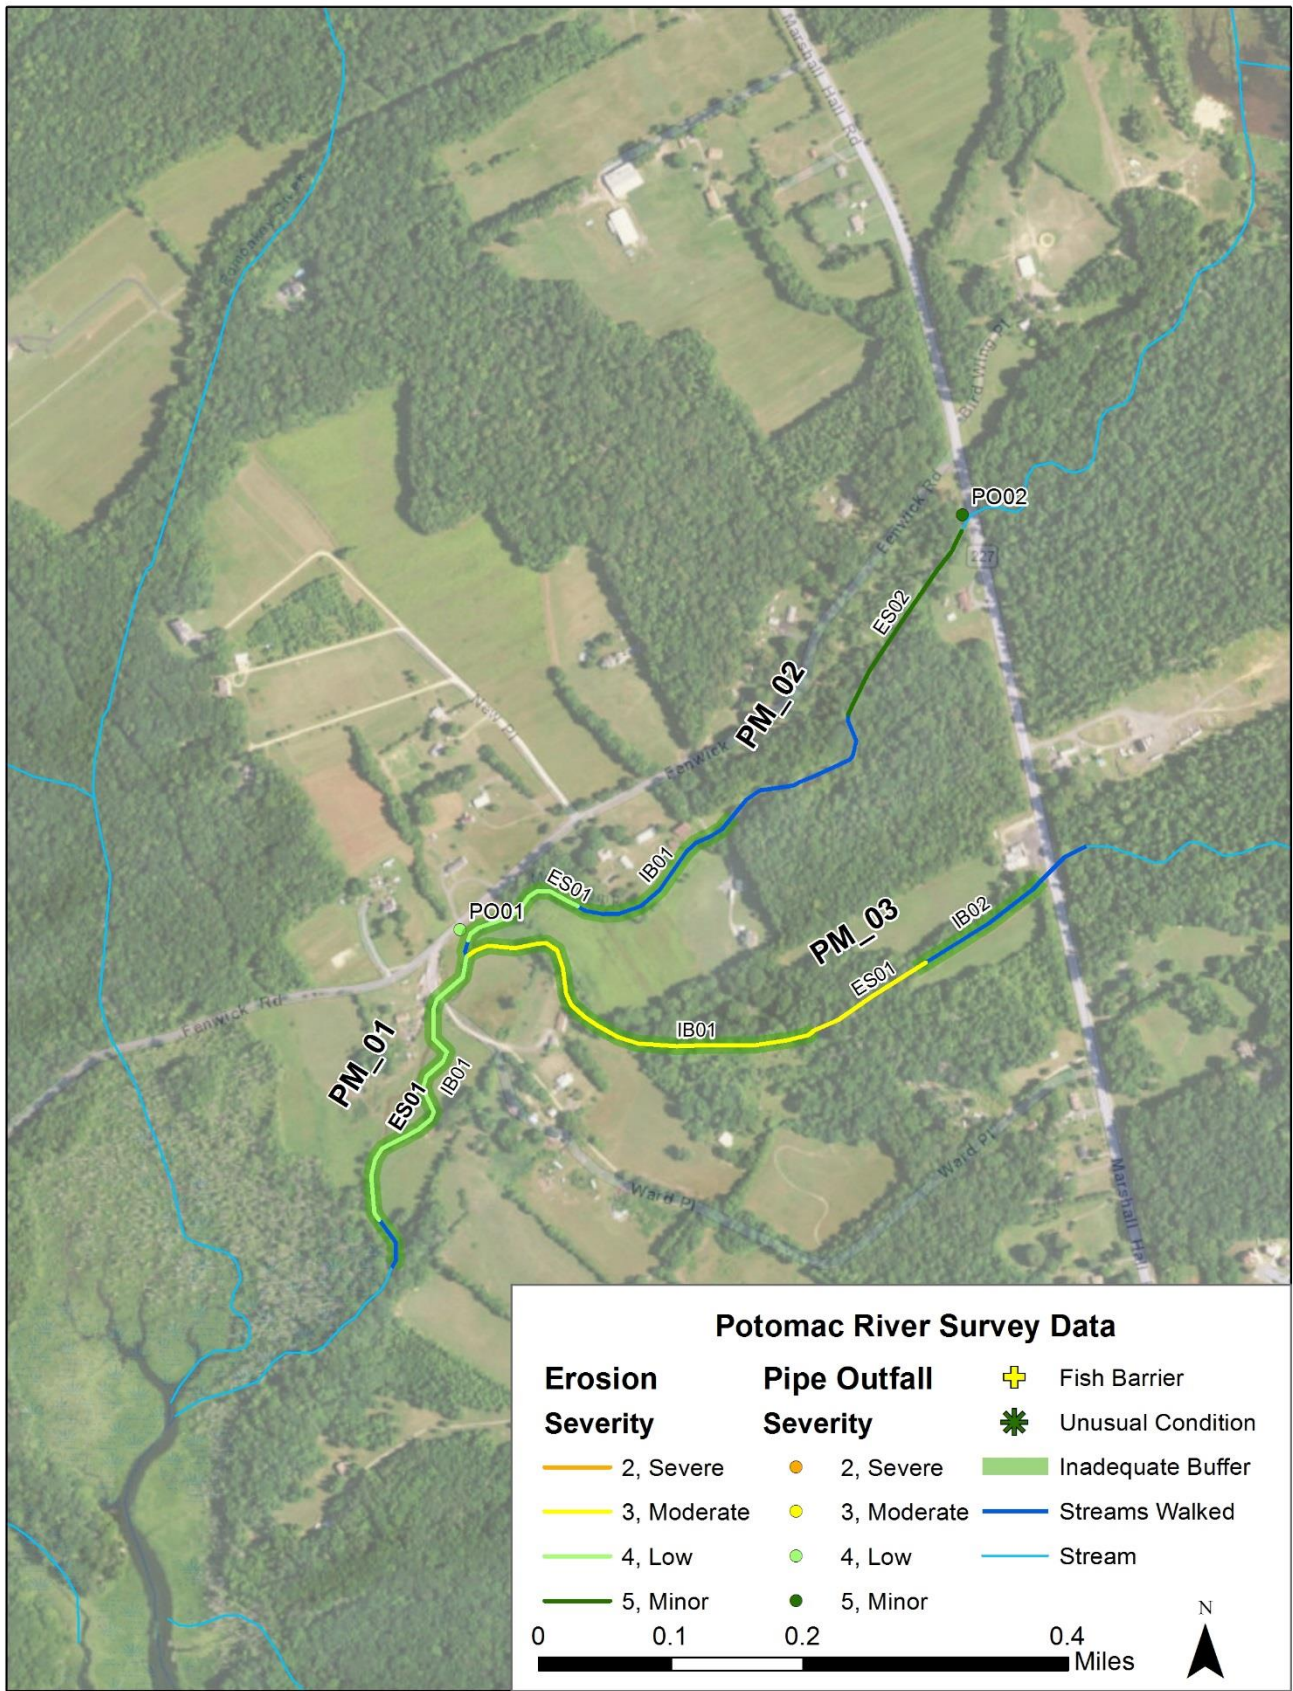
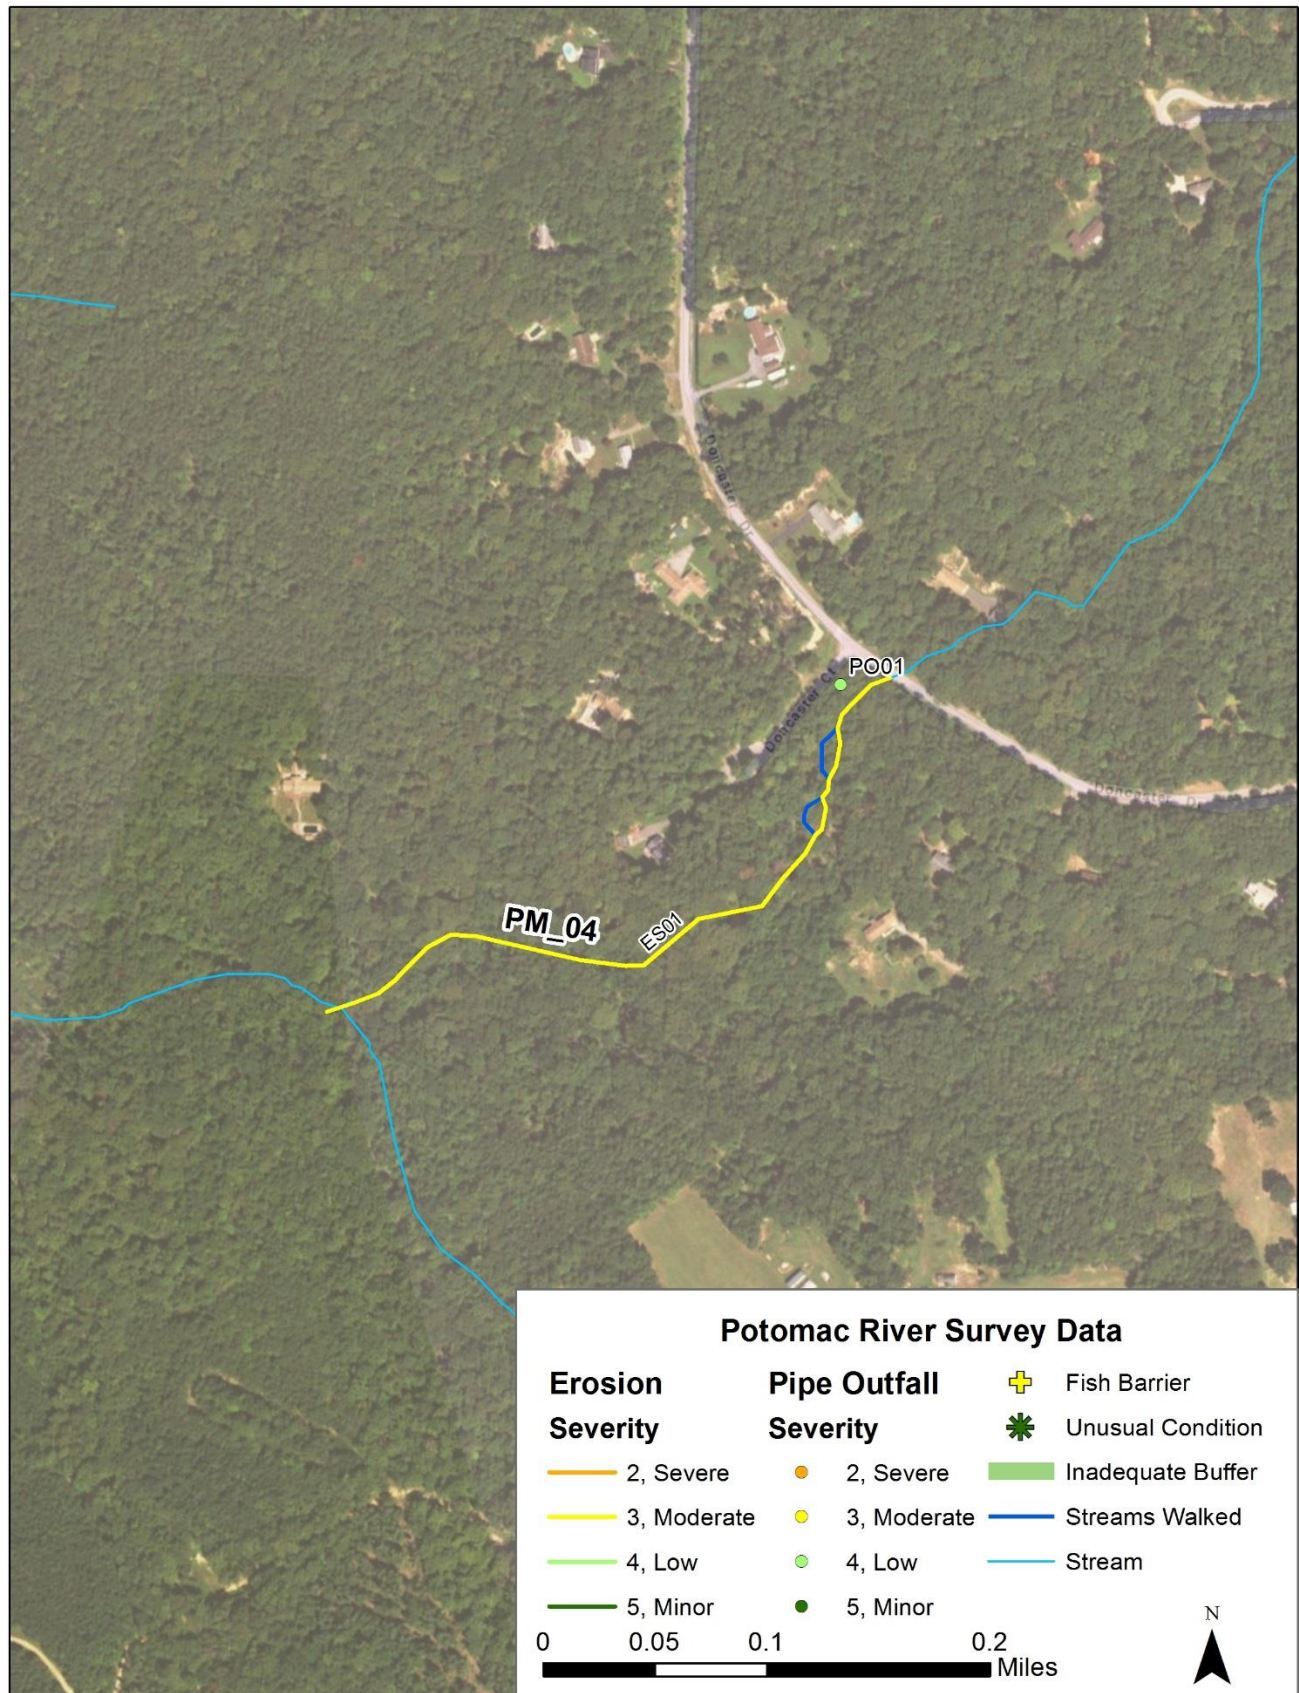
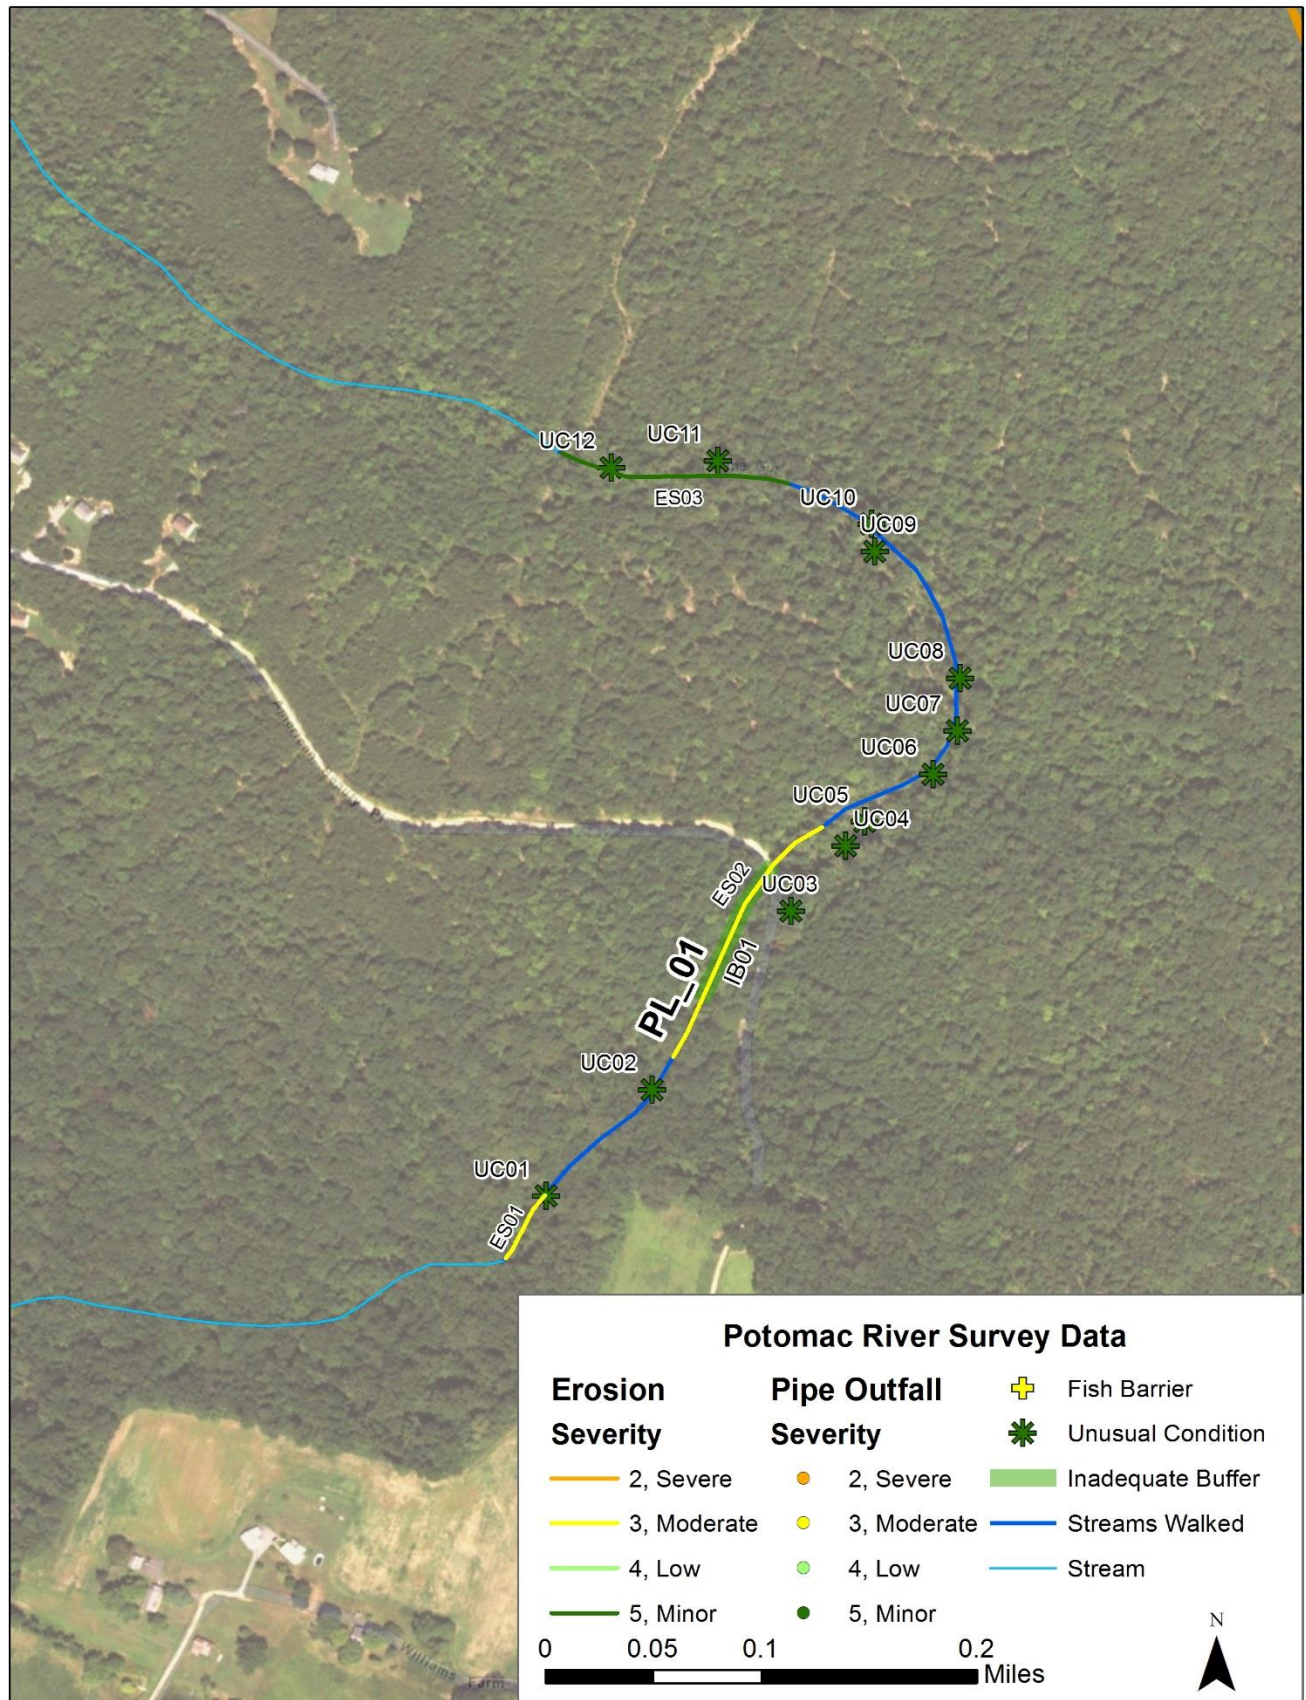
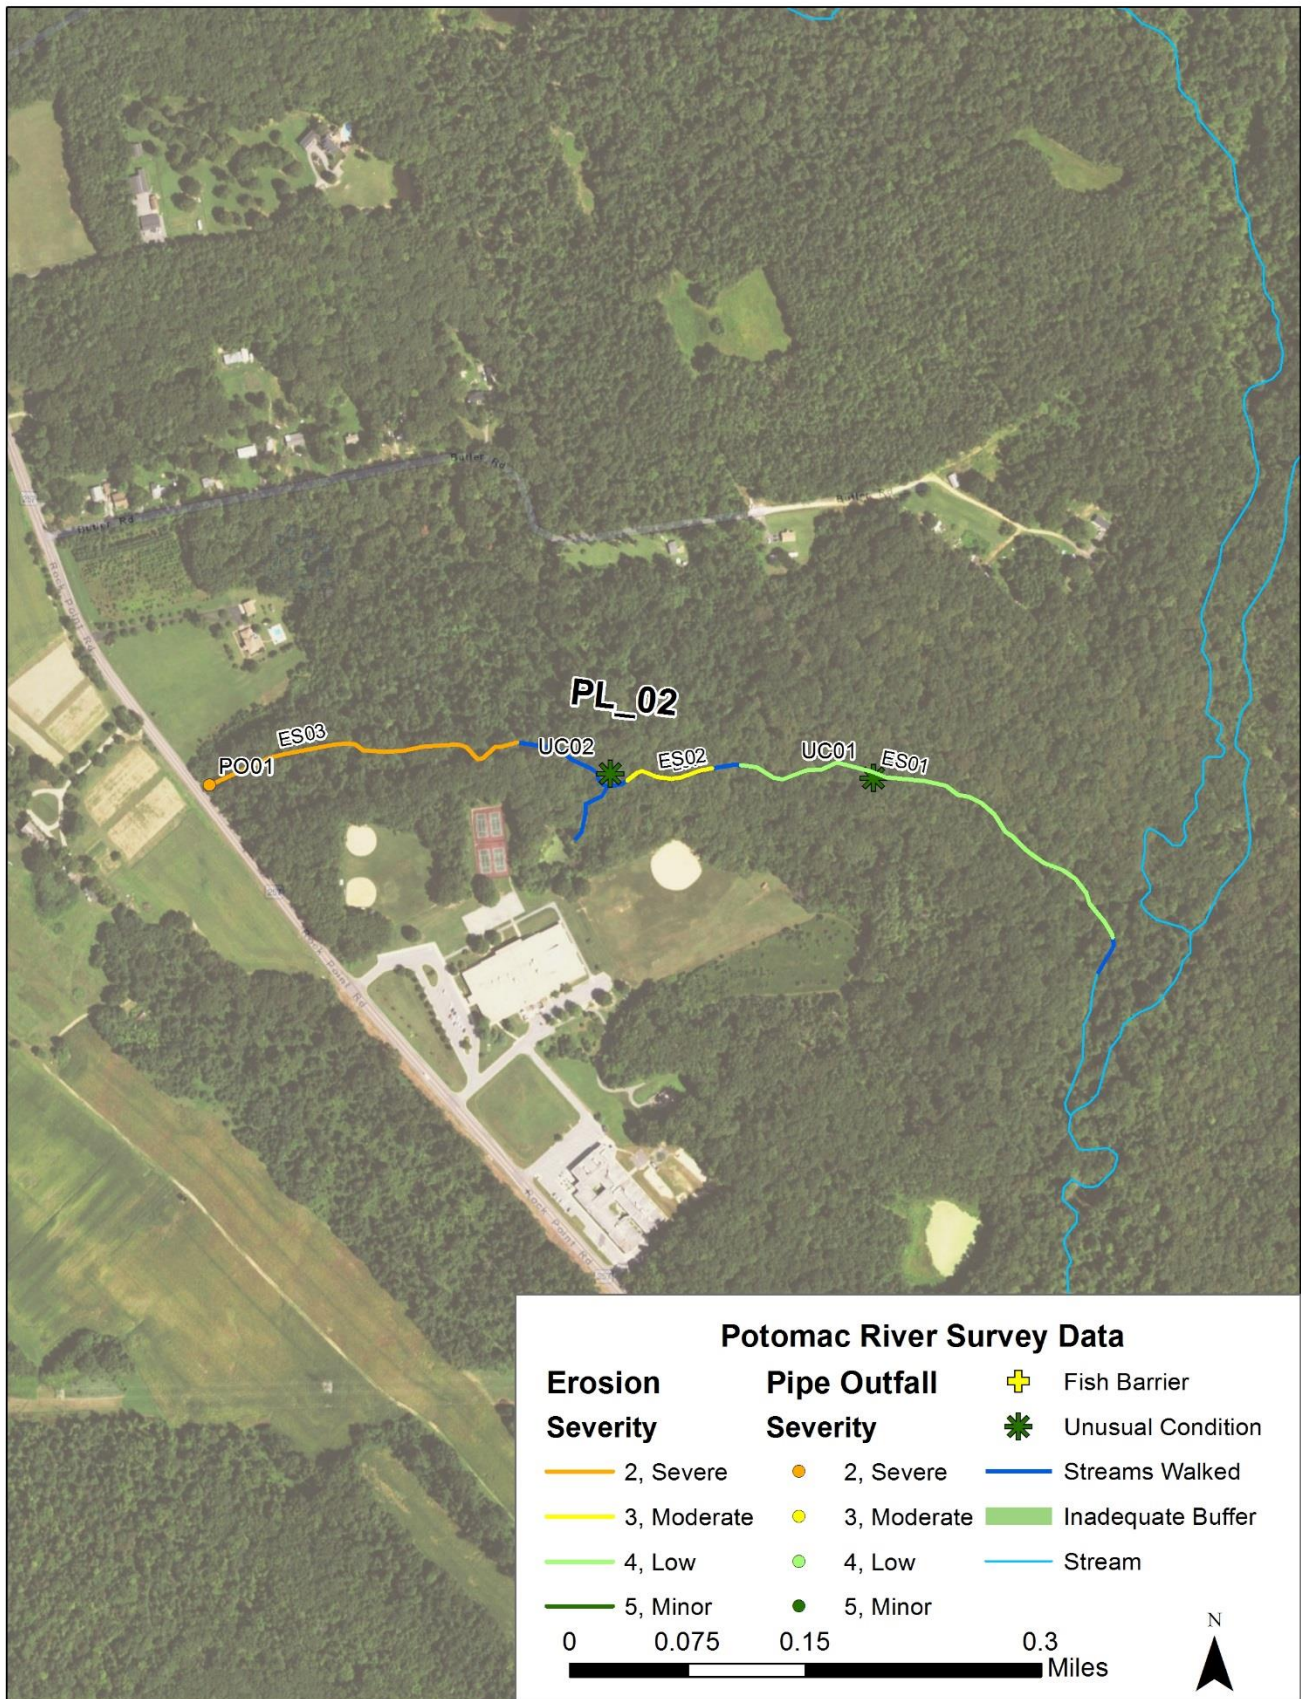
Twenty erosion sites totaling 3.9 miles were identified. The stream erosion process was identified as widening for eight sites (40%), downcutting for six sites (30%), headcutting for one site (5%), and both downcutting and widening for five sites (25%). While collecting stream erosion data, field crews also attempted to determine the leading possible cause of erosion at each site. The most commonly described possible causes for erosion was landuse change upstream (50%). Other sources include agricultural drainage (25%), pipe outfall (15%), and removal of forest buffer (10%). Three sites were determined to pose a potential threat to an adjacent roadway. Locations of erosion sites can be found in Figure 29 through Figure 34.

Inadequate buffers, defined as buffers less than 50 feet wide from the edge of the stream, were identified at 7 sites, totaling 1.2 miles of inadequate buffers. Approximately 86% of the inadequate buffer length identified was affecting both sides of the stream channel. Agriculture (crops, pasture, old field) was the cause of the inadequate buffer at 86% the sites, while a gravel road accounted for 14% of the inadequate buffer sites. The location of reaches with inadequate buffers is displayed in Figure 29 through Figure 33.

Two pipe outfalls were identified as road crossings, but all other pipe outfalls were associated with stormwater conveyance. Any observed discharge was clear and odorless. Locations and severity of these points are shown in Figure 29 through Figure 33.

There were fourteen unusual condition/comment points identified in the study area. Twelve points were taken to document the location of a beaver dam. One point (PL\_R02\_UC01) was taken to record the presence of a debris jam which was causing a fish barrier and one point (PL02\_UC02) was taken to document an eroded stormwater management pond outfall channel from a pond. The location of the unusual condition points is displayed in Figure 29 through Figure 33.

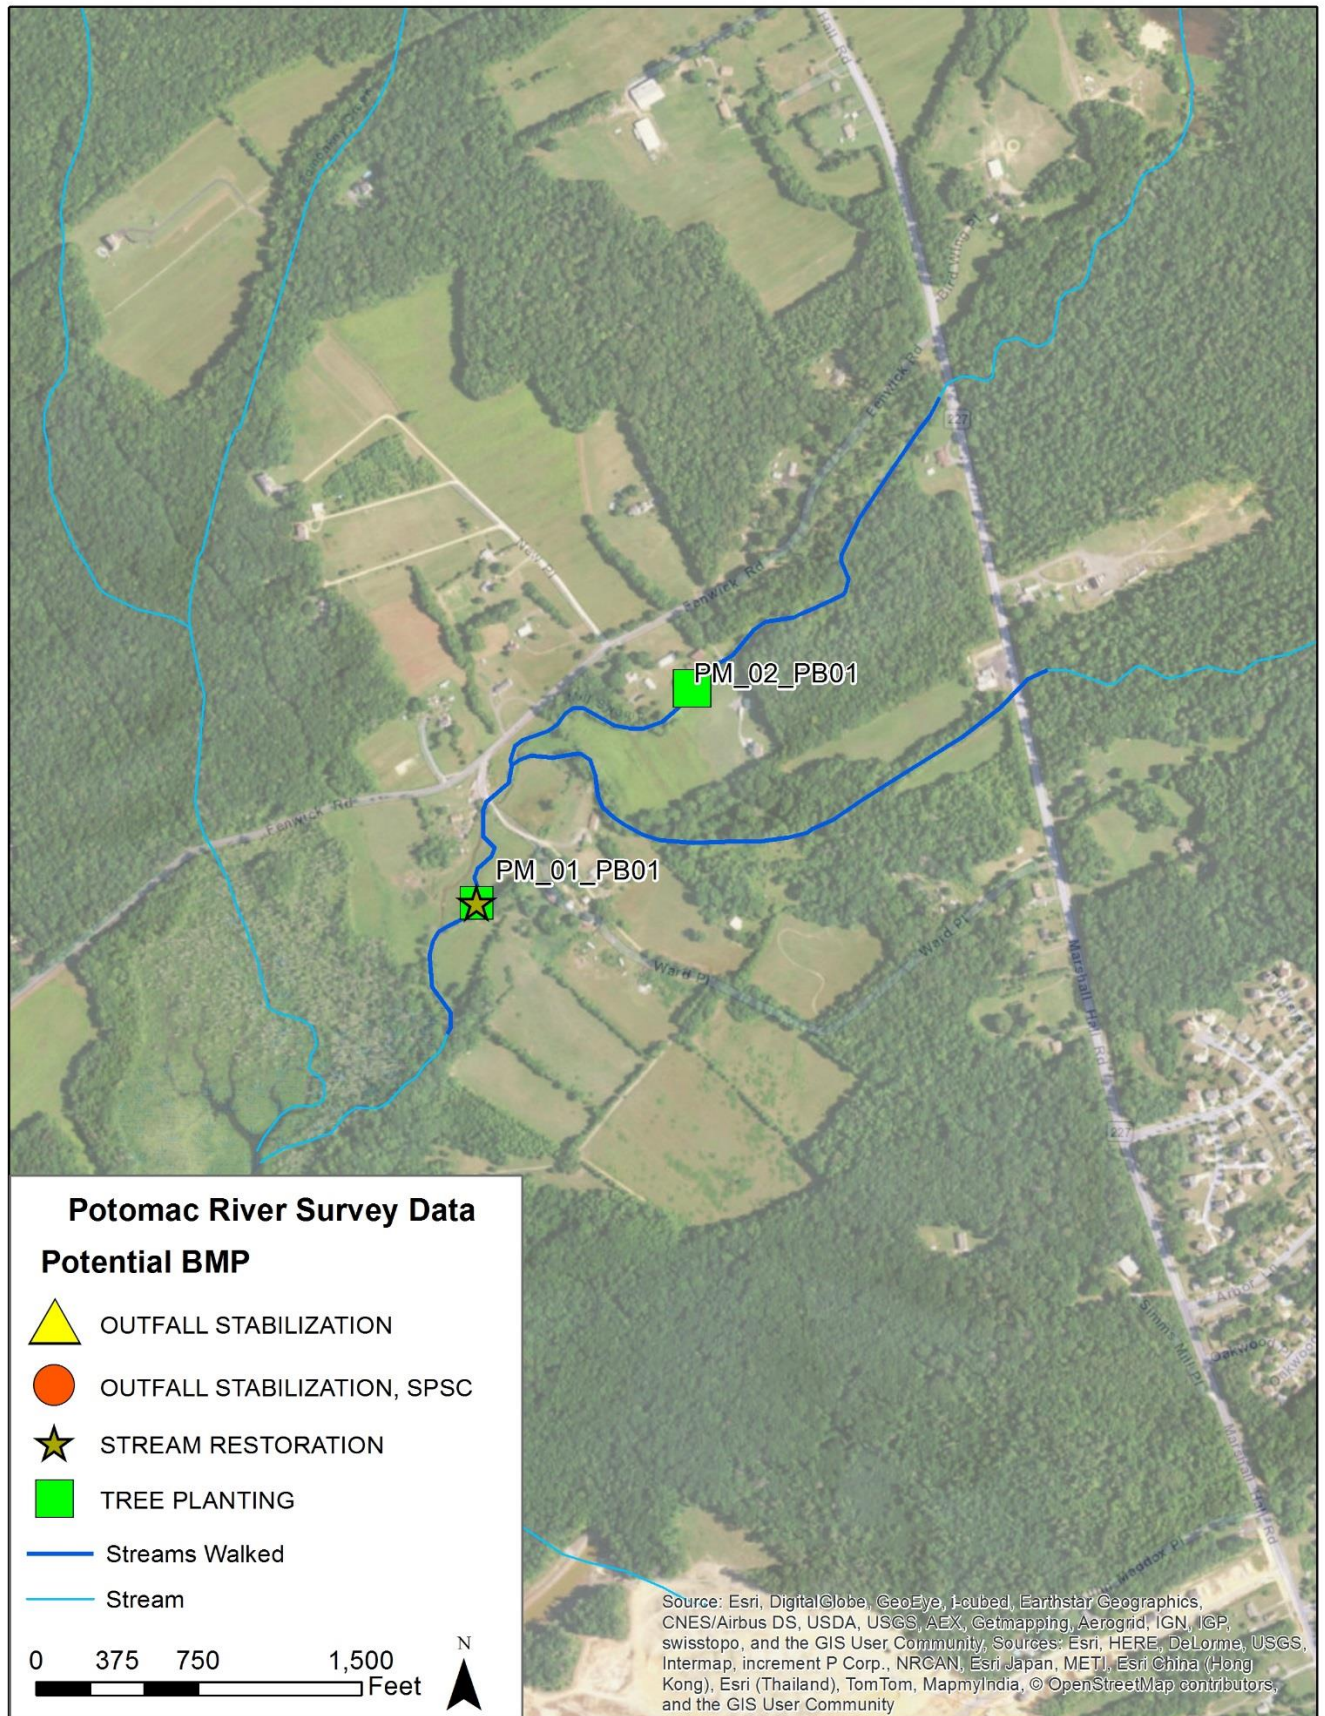
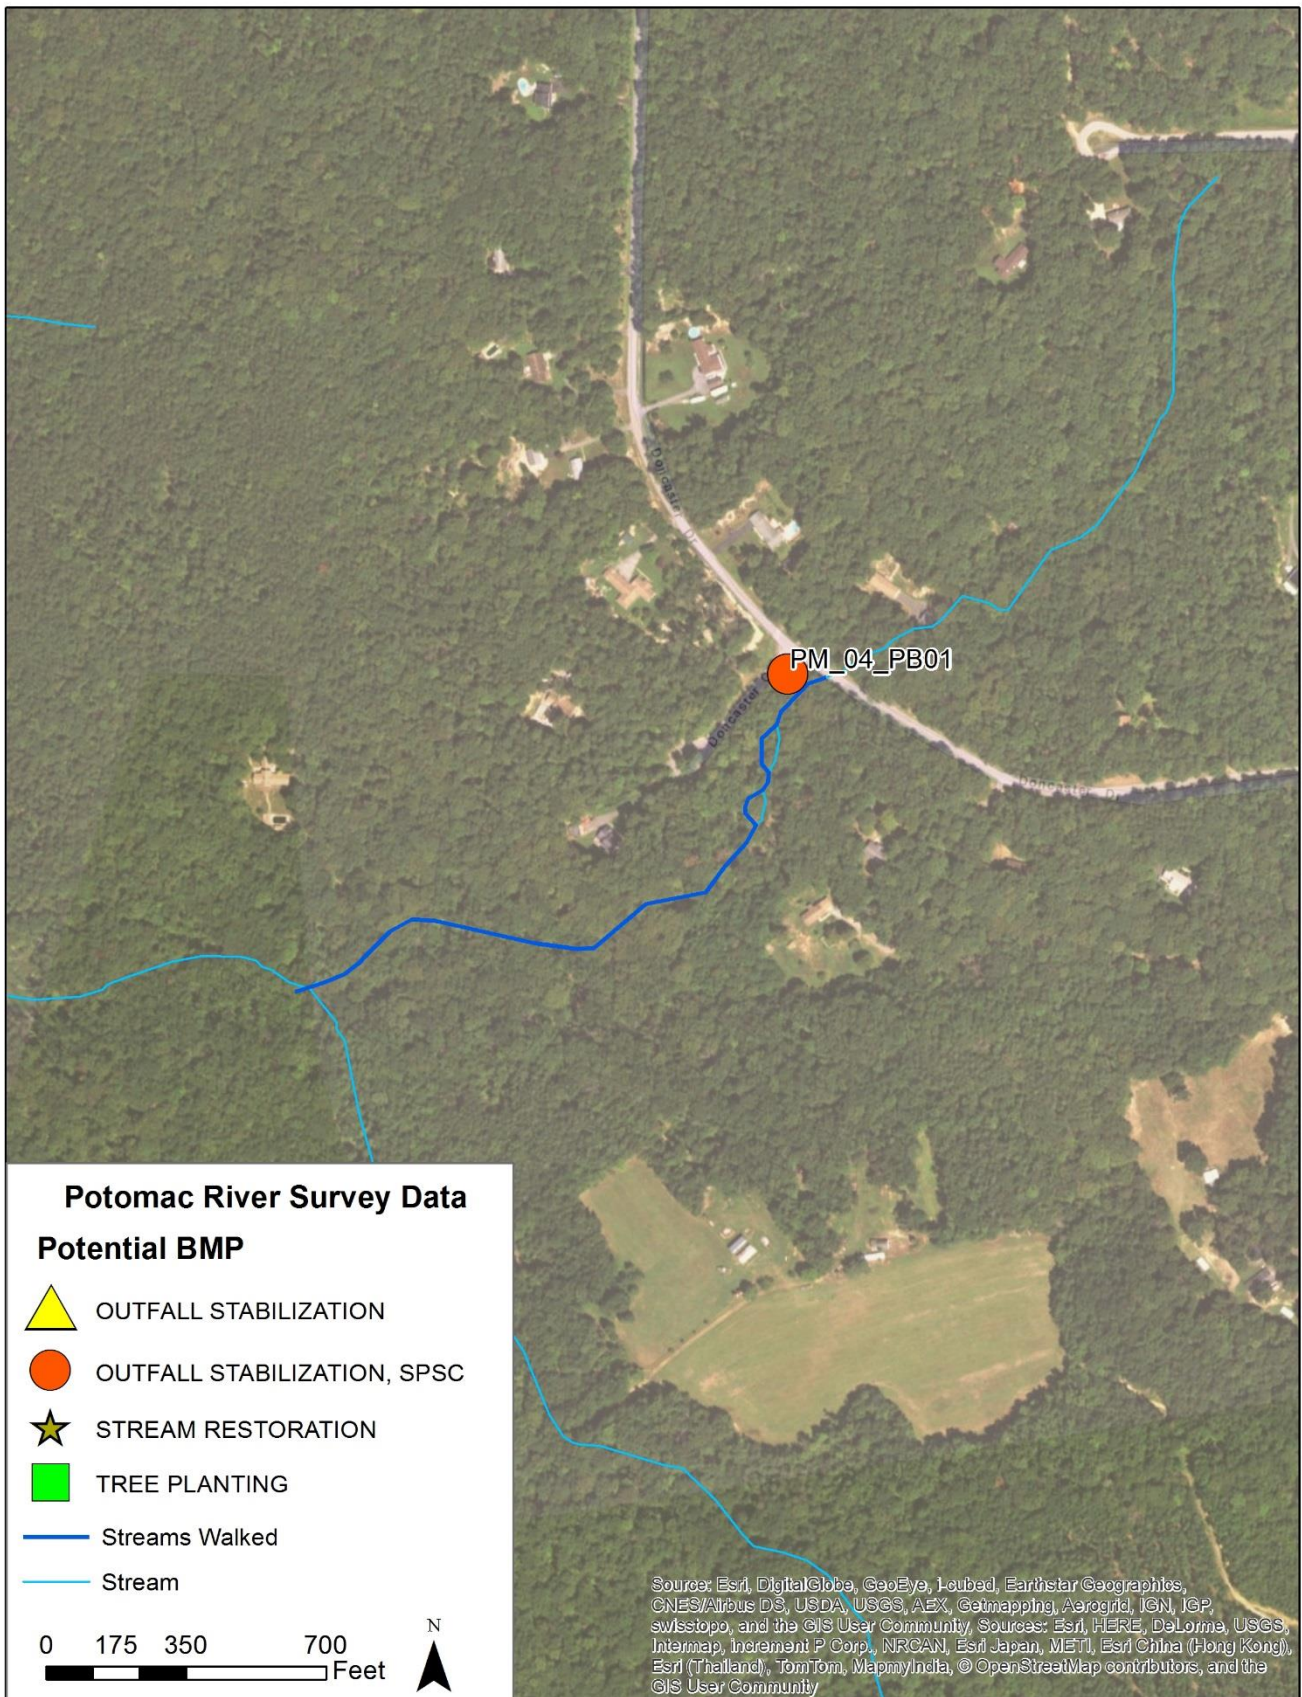
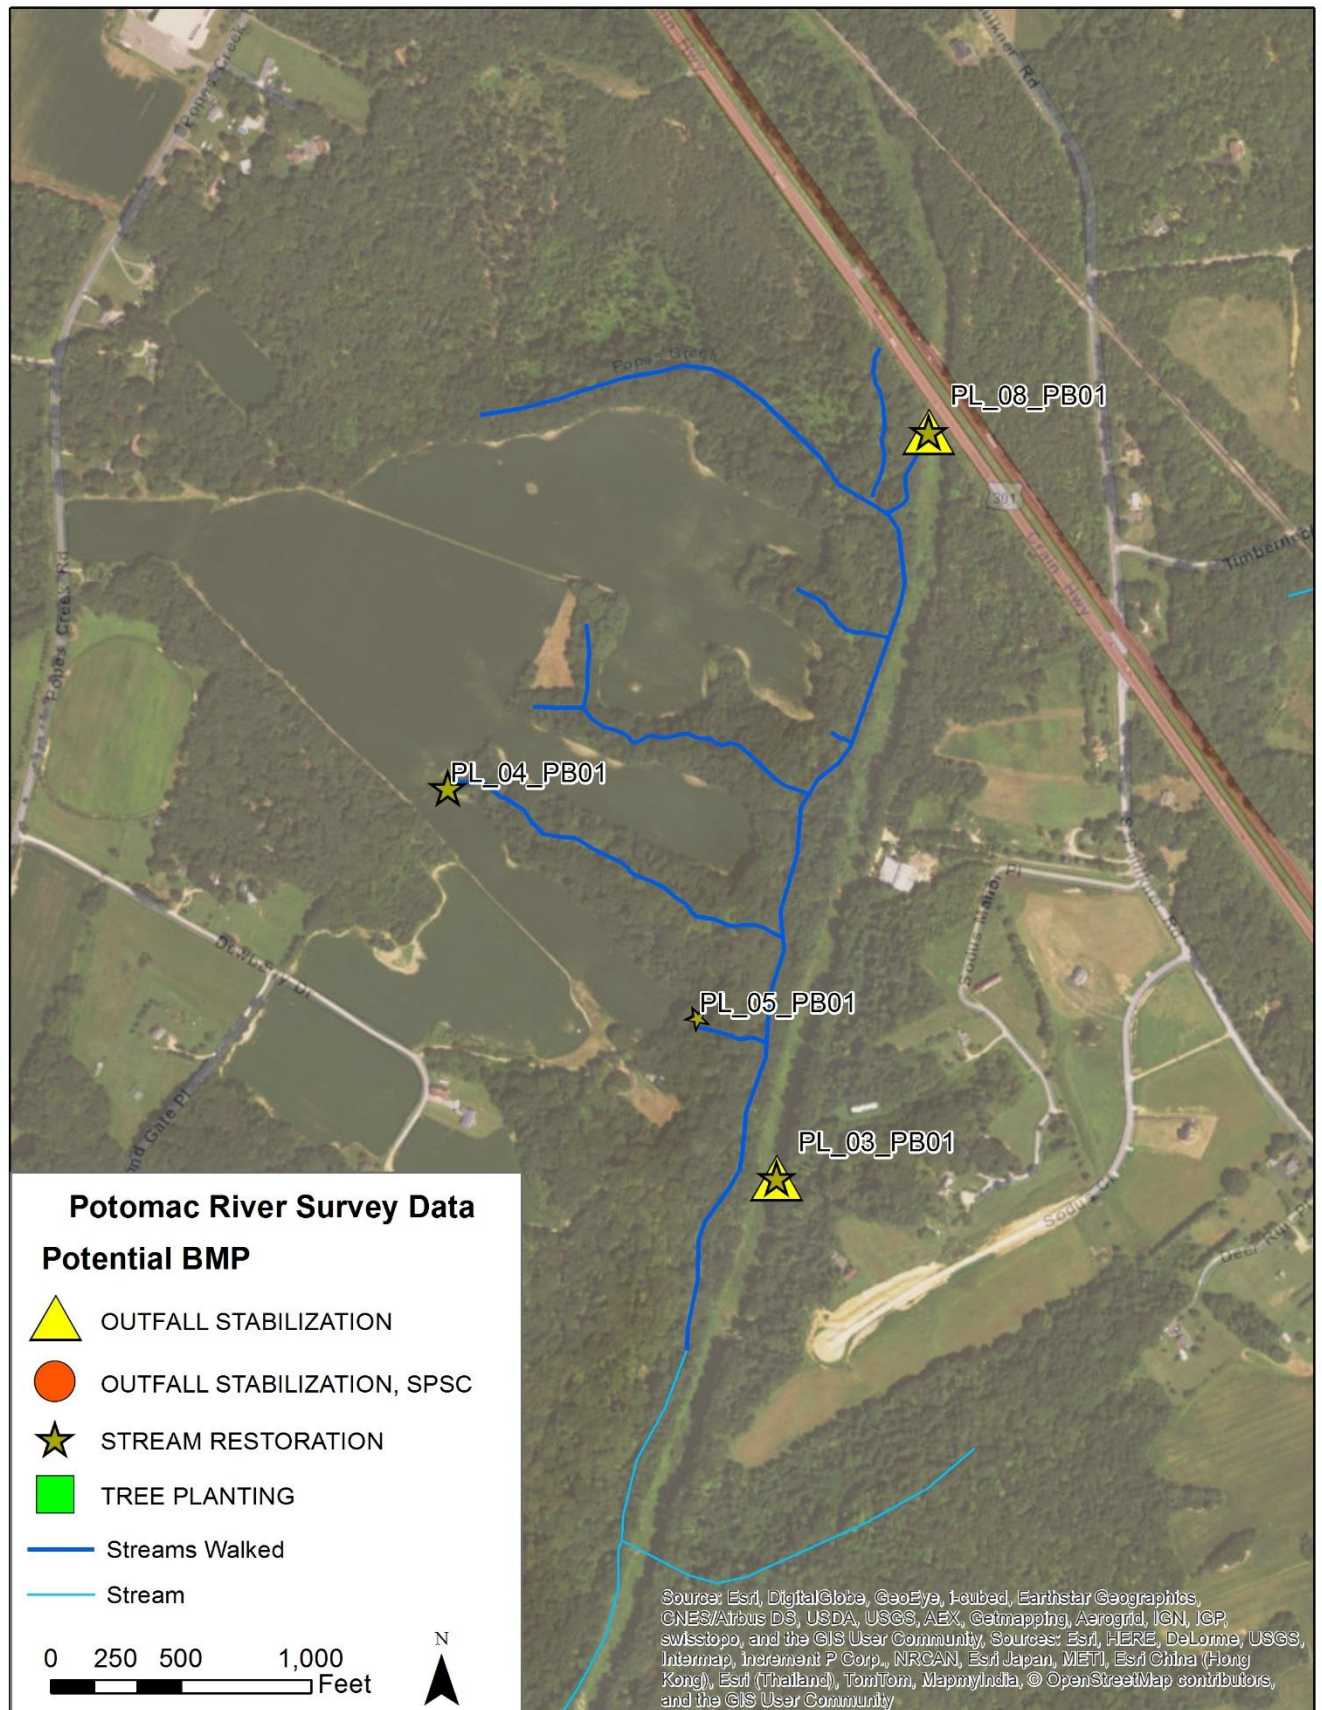
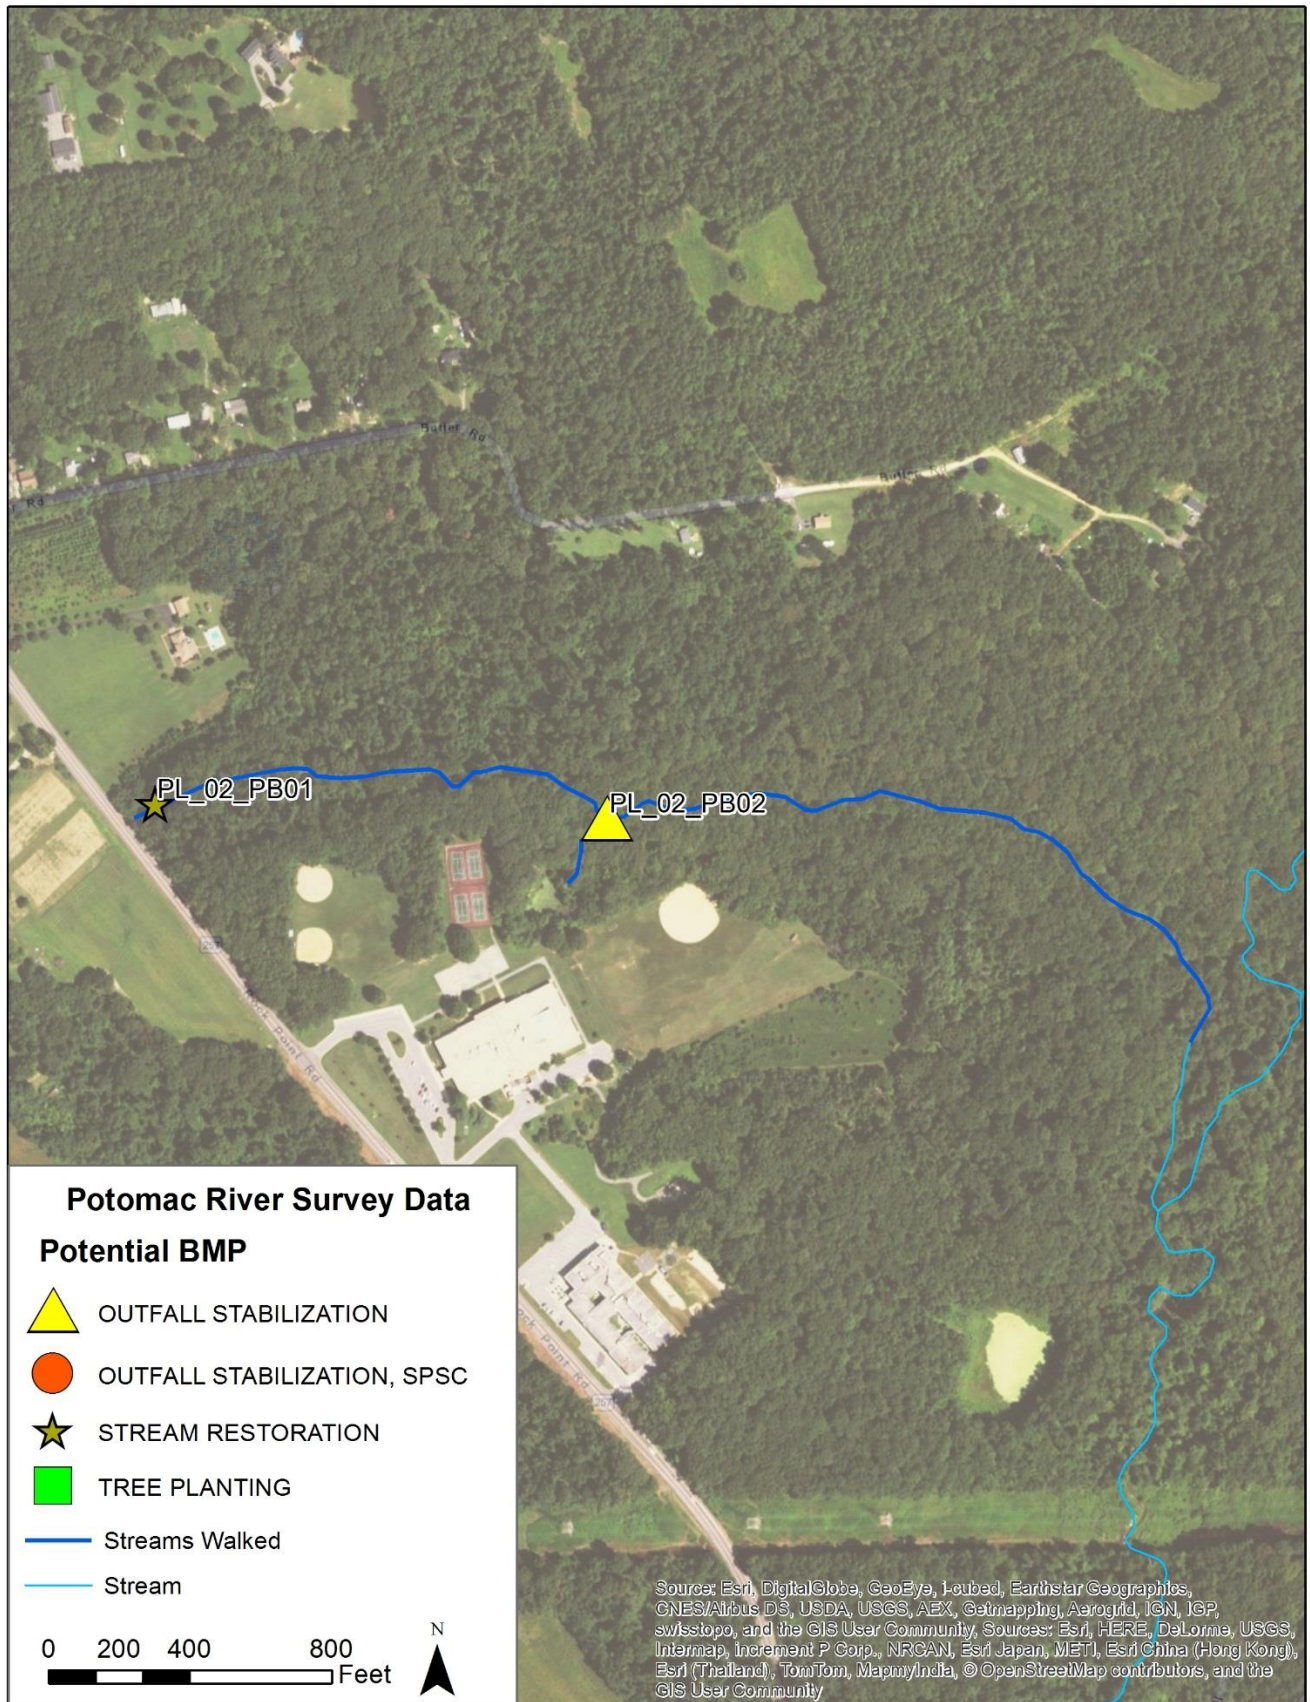
Nine initial potential improvement sites were identified during the SCA fieldwork. Recommended BMP types include, riparian buffer enhancement (two sites), stream restoration/outfall stabilization (six sites), and SPSC/outfall stabilization (two sites). More than one BMP type was suggested at one site. The locations of these preliminary sites as well as the primary BMP type are displayed in Figure 34 through Figure 37. These projects were further expanded and are presented in the following section.

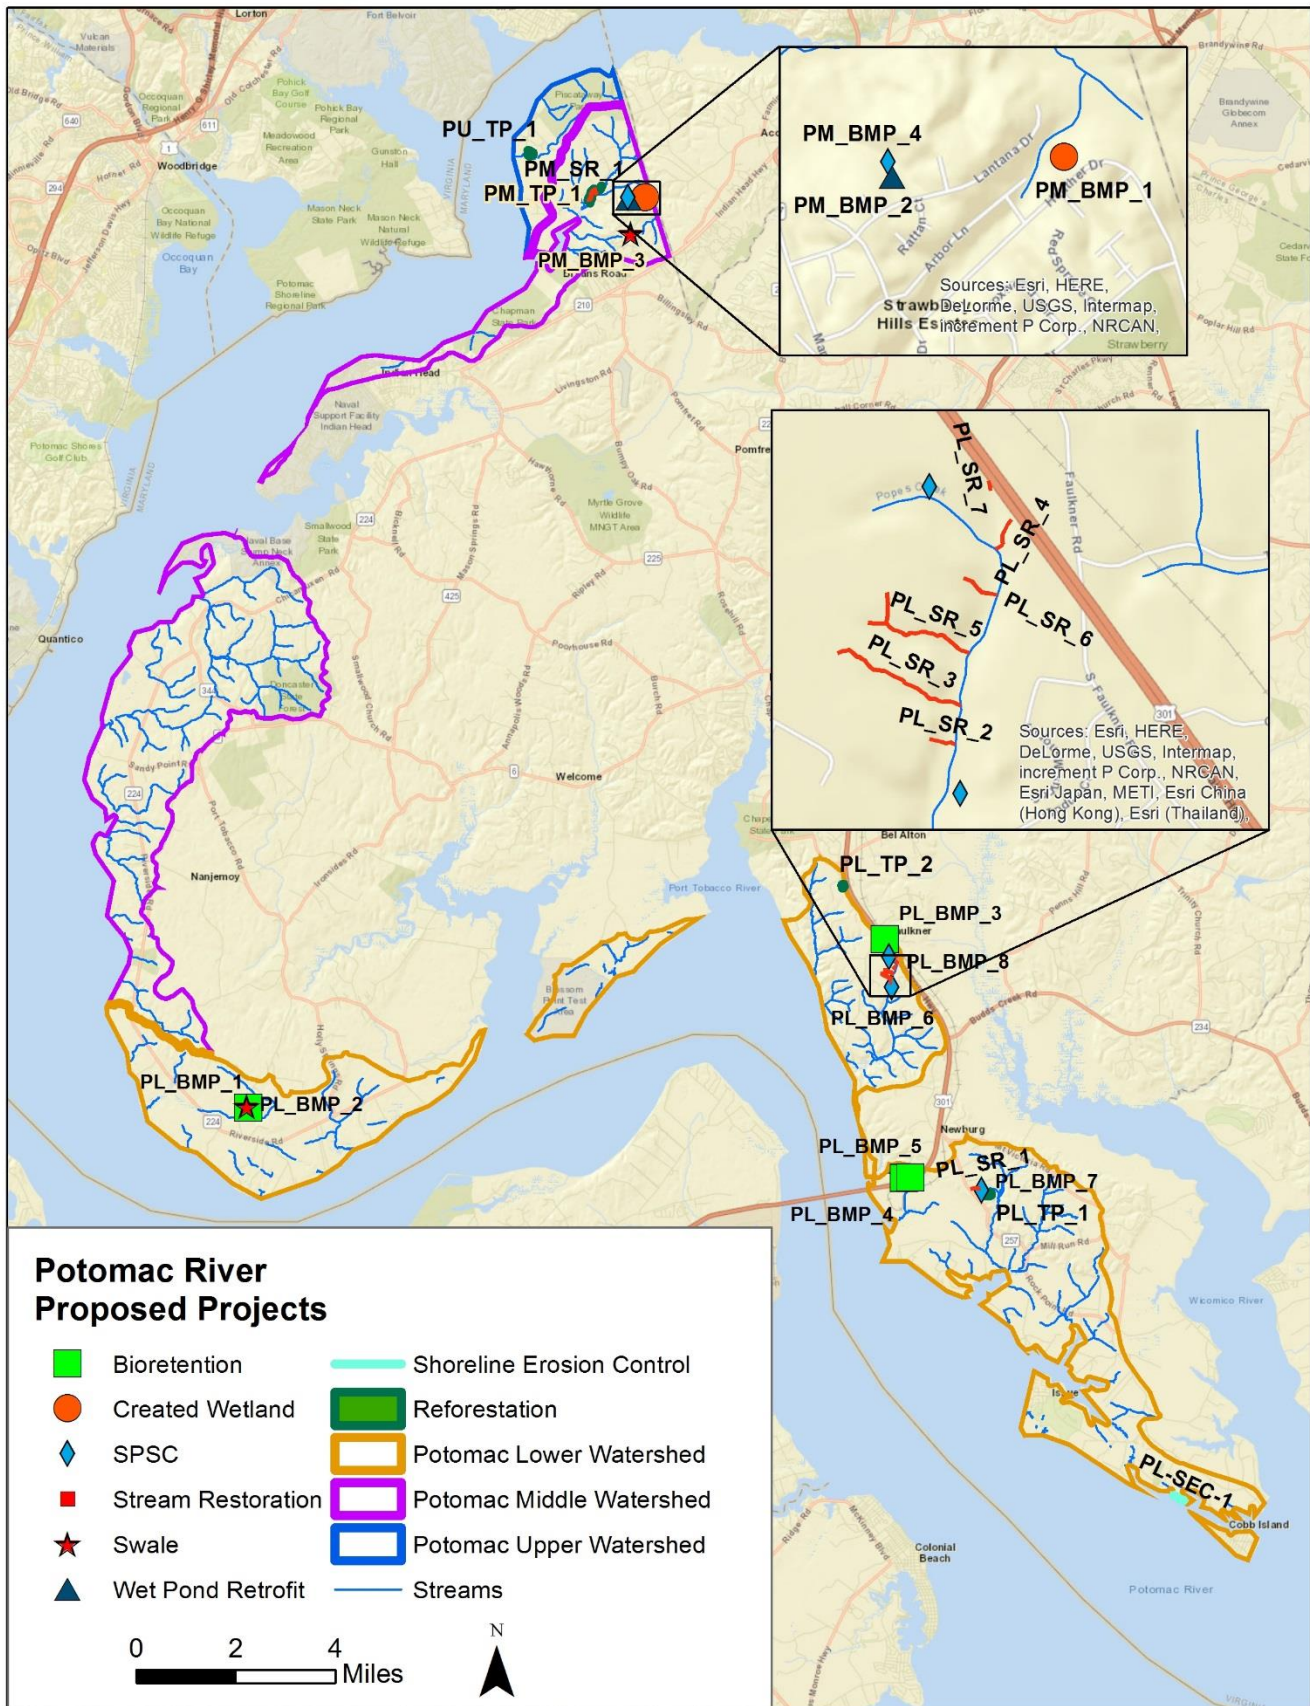
FIGURE 38: LOCATION OF POTOMAC RIVER WATERSHED POTENTIAL WATER QUALITY IMPROVEMENT PROJECTS- LEVEL 9 PROJECTS IDENTIFIED IN THIS WATERSHED ASSESSMENT

The BMP facility types that were identified include bioretention, dry swale, created wetland, step pool storm conveyance, and wet pond retrofit. Table 18 below includes a brief discussion of the existing site conditions and the proposed site improvements. Table 19 contains a summary of the impervious area treated by the proposed BMP types. BMP locations are displayed in Figure 38.
